Structural Repair  
and Protection  
Cost Estimate  
and Attendant  
Condition  
Appraisal of the  
Miami Marine  
Stadium

Miami, FL  
January 2010

SGH Project 090457

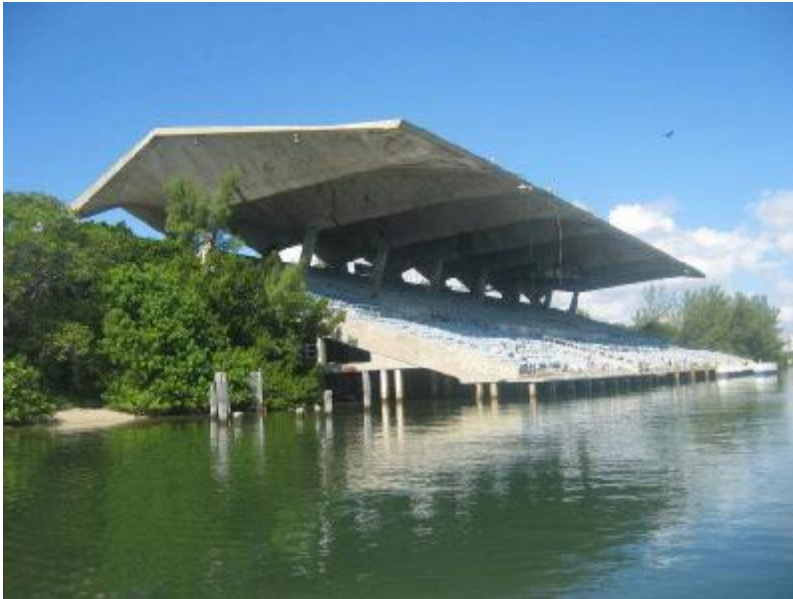
**Photo 1**

Overall view of the Miami Marine Stadium.

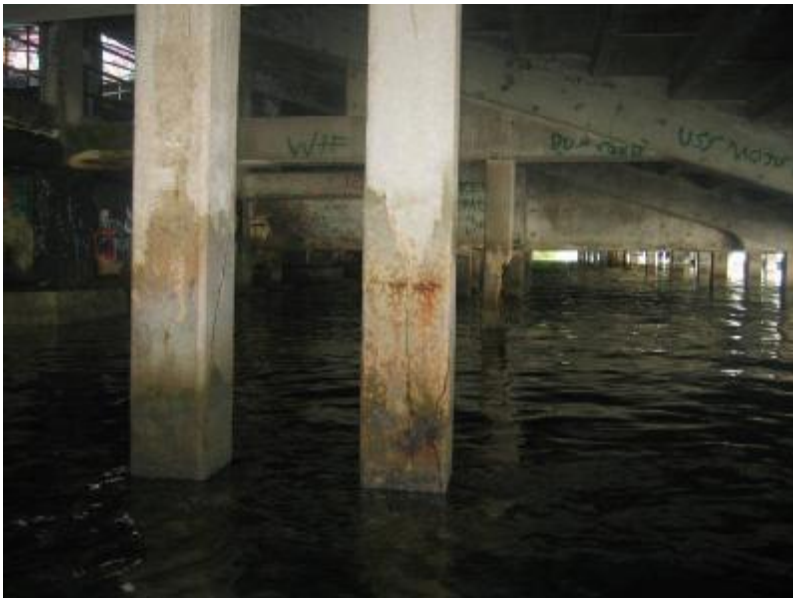
**Photo 2**

Piles showing moderate deterioration.

- Repair delaminated and spalled concrete on exposed piles.
- Install new piles to supplement deteriorated exposed piles.

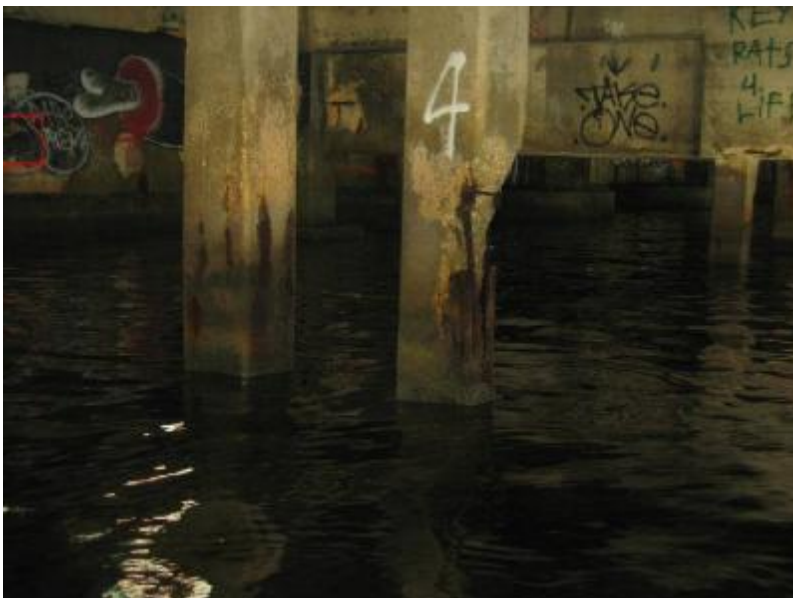
**Photo 3**

Piles showing severe deterioration with section loss.

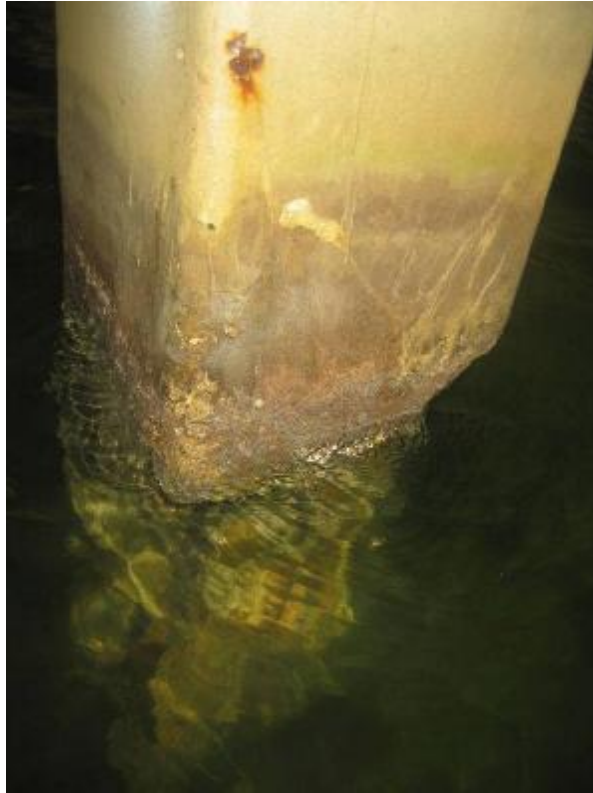
**Photo 4**

Pile with severe deterioration below the water level.

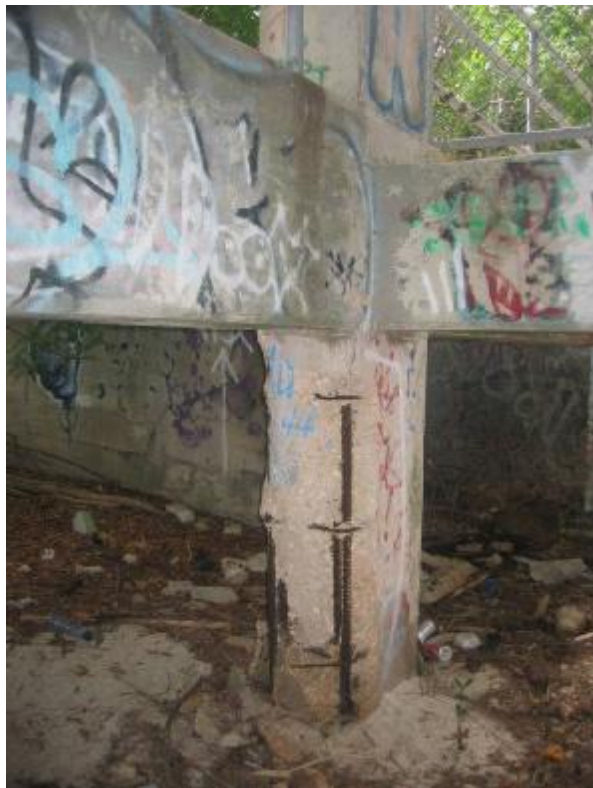
**Photo 5**

Column at open area with large spalls.

- Repair delaminated and spalled concrete on the seawall.
- Repair delaminated and spalled concrete on the topside of the slabs.
- Repair delaminated and spalled concrete on columns.
- Remove and replace severely deteriorated beams, slabs and columns.

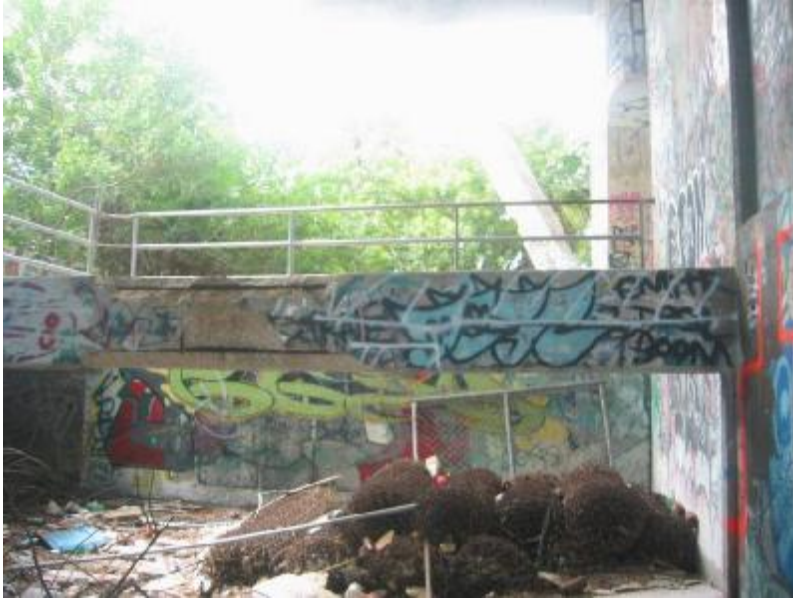
**Photo 6**

Beam at open area with large spalls.

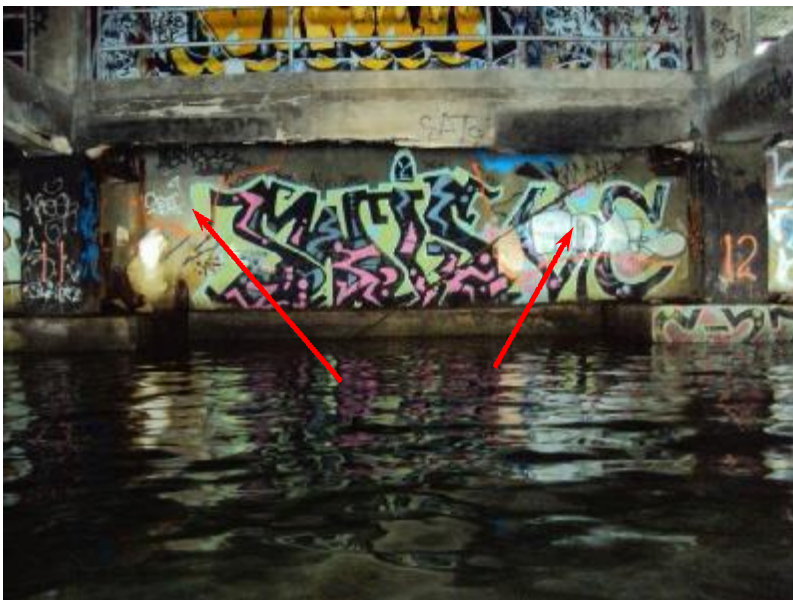
**Photo 7**

Seawall section with delaminated areas. Extent of delamination is bounded by the orange paint.

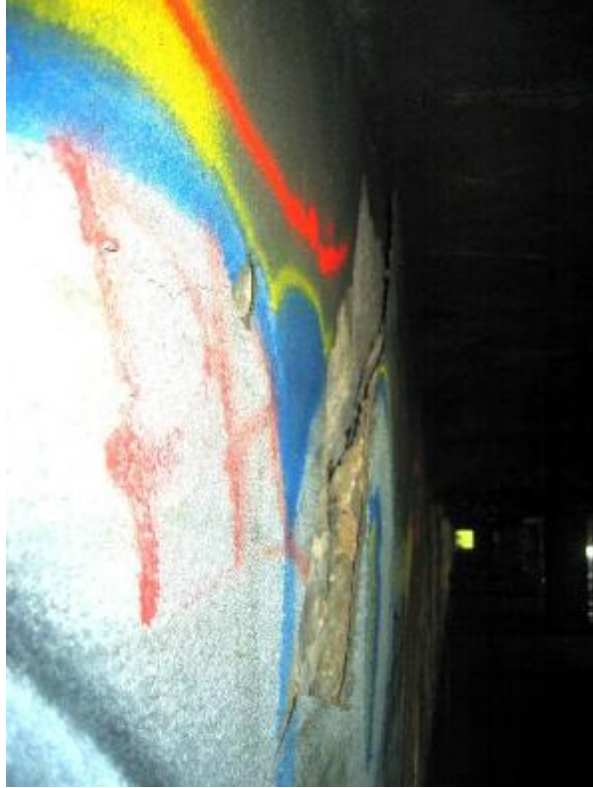
**Photo 8**

Delamination in seawall.

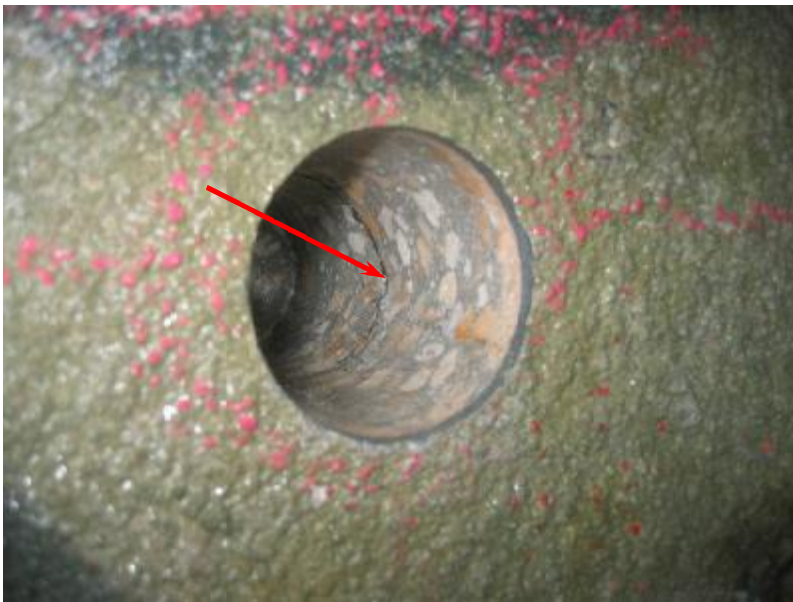
**Photo 9**

Internal crack in seawall  
caused by corrosion of  
reinforcement.

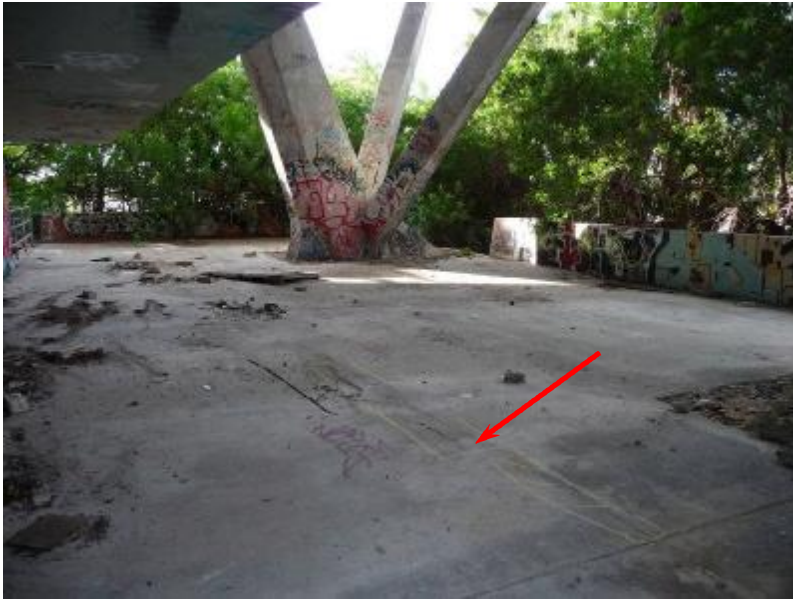
**Photo 10**

Deterioration on topside ground level slab.

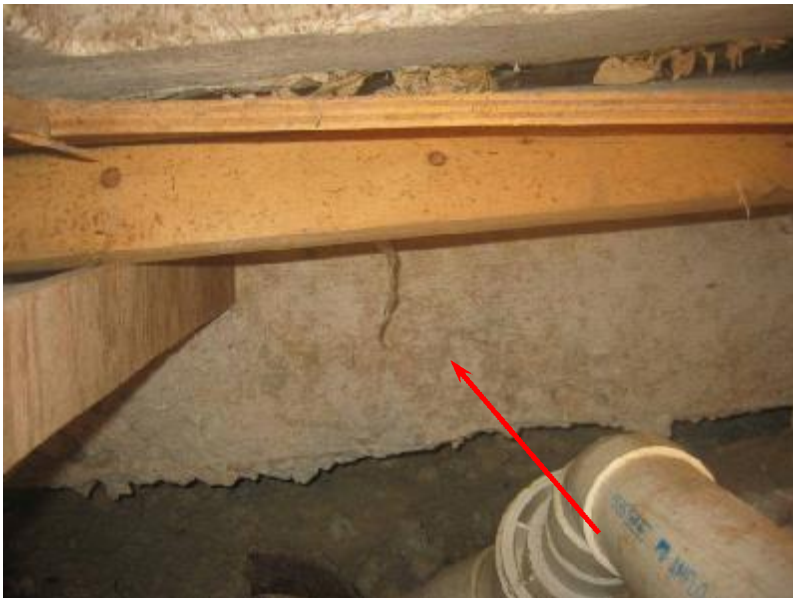
**Photo 11**

Grade beam in good condition.

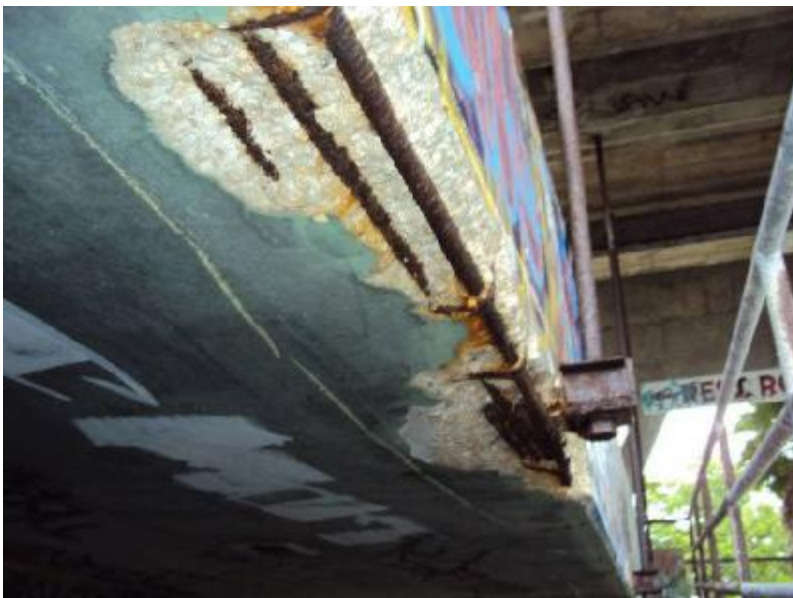
**Photo 12**

- The steel hangers supporting the mezzanine slab and adjacent concrete show severe deterioration (Photo 12).
- The ramp and mezzanine slabs show moderate deterioration with localized spalls or delaminations (Photos 13 and 14)

Deterioration at hanger location.

- Repair delaminated and spalled concrete on the topside, underside and edges of the slabs.
- Replace deteriorated steel hangers and connectors supporting the mezzanine slab.

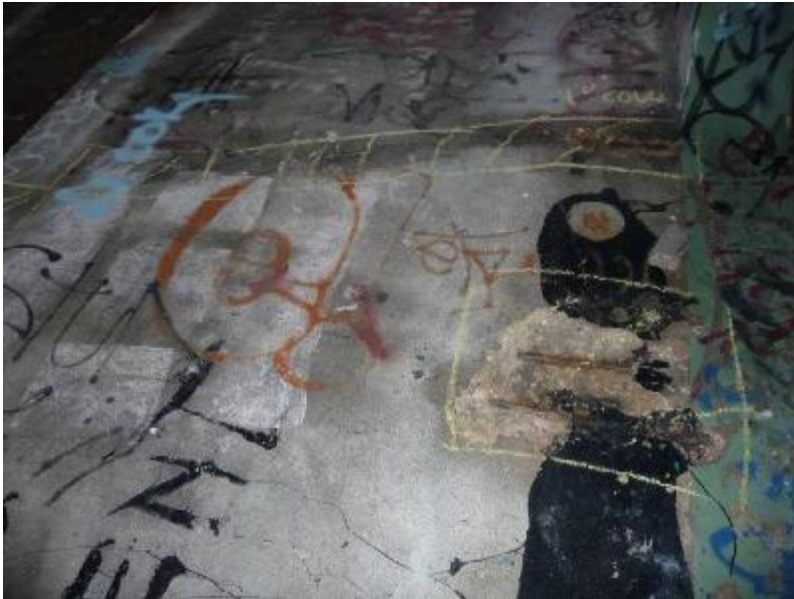
**Photo 13**

Deterioration on topside of ramp slab.

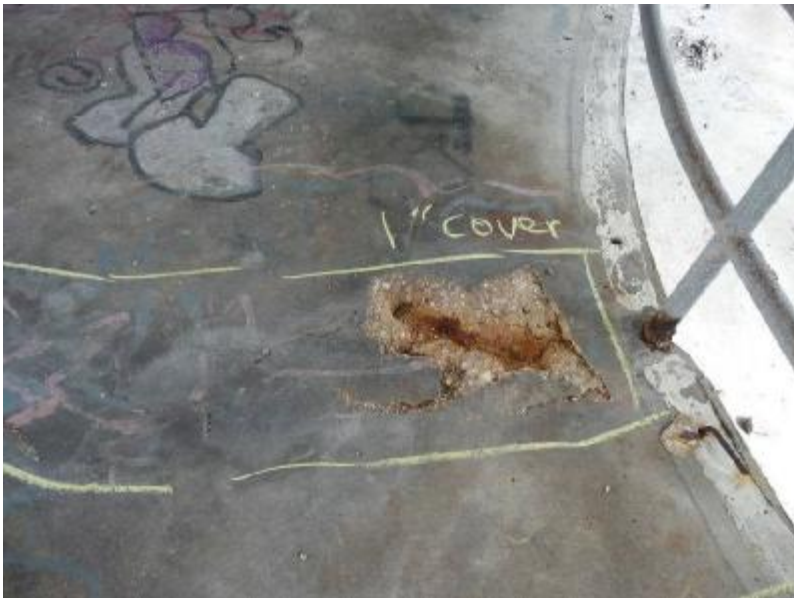
**Photo 14**

Deterioration on topside of mezzanine slab.

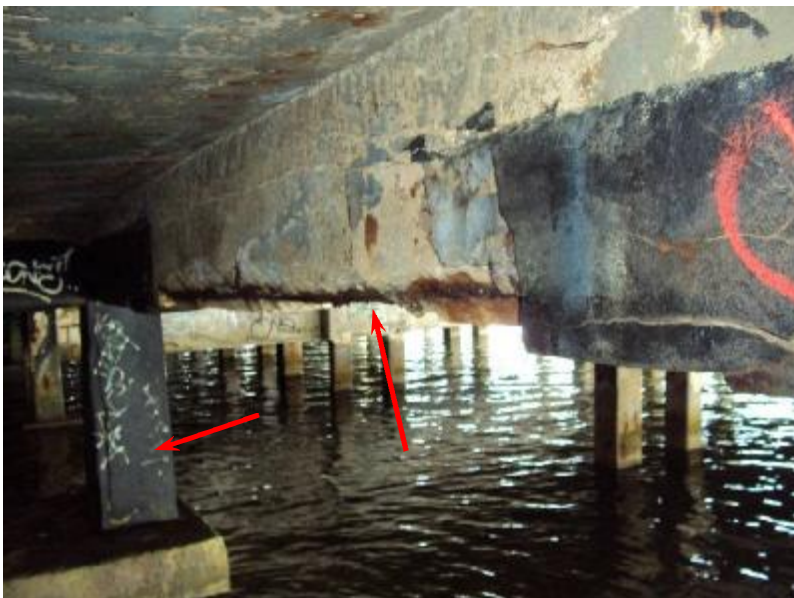
**Photo 15**

Beam and column along column line E showing severe deterioration.

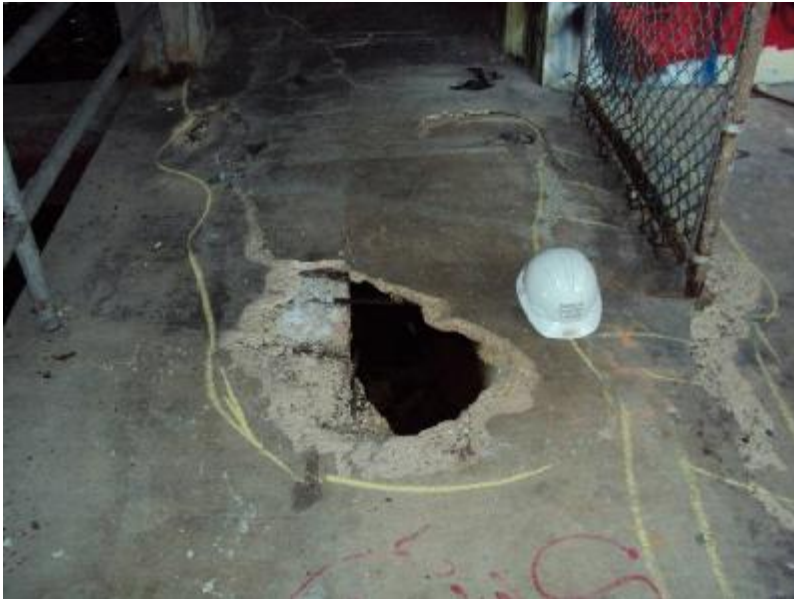
**Photo 16**

Slab showing severe deterioration.

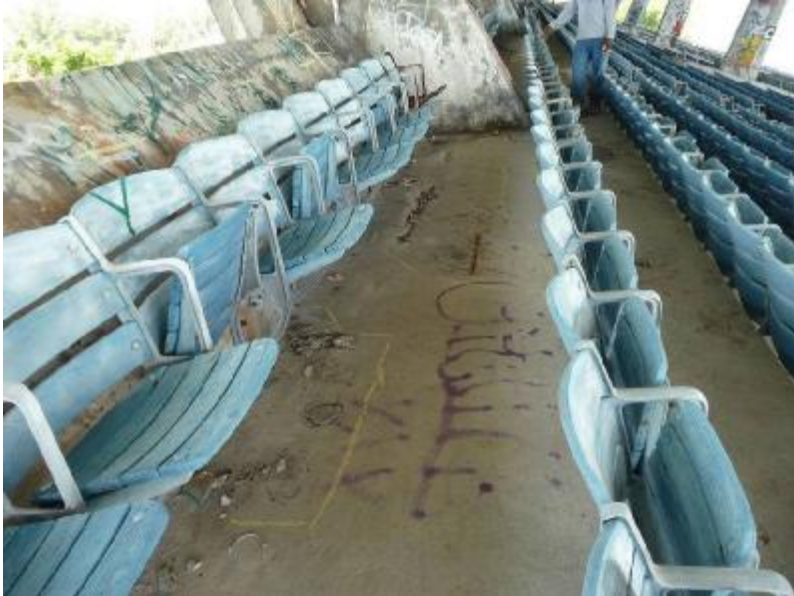
**Photo 17**

Deterioration on the topside of seating slab.

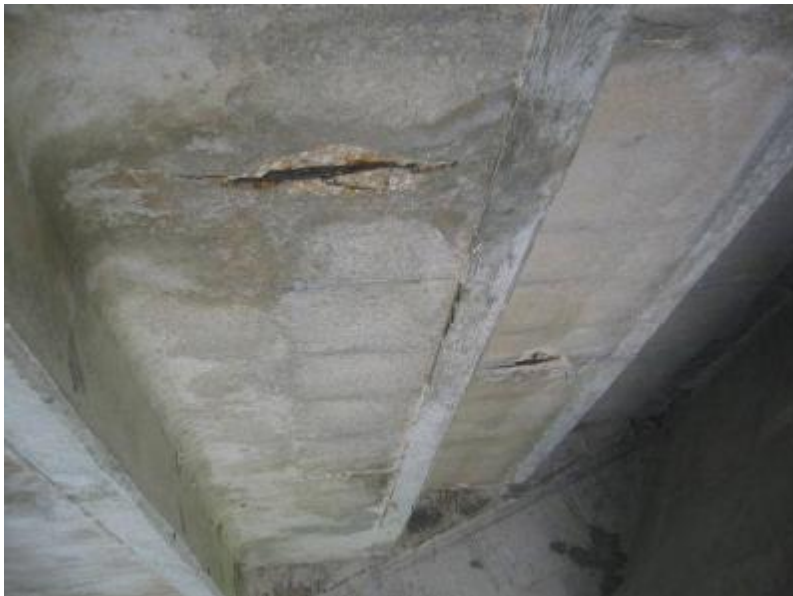
**Photo 18**

Deterioration on the bottom side of seating slab.

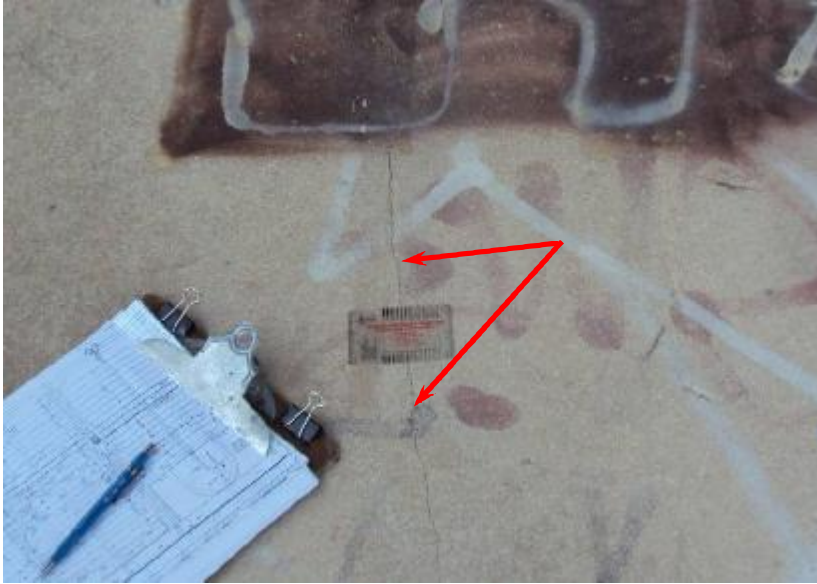
**Photo 19**

Crack on top side of seating slab.

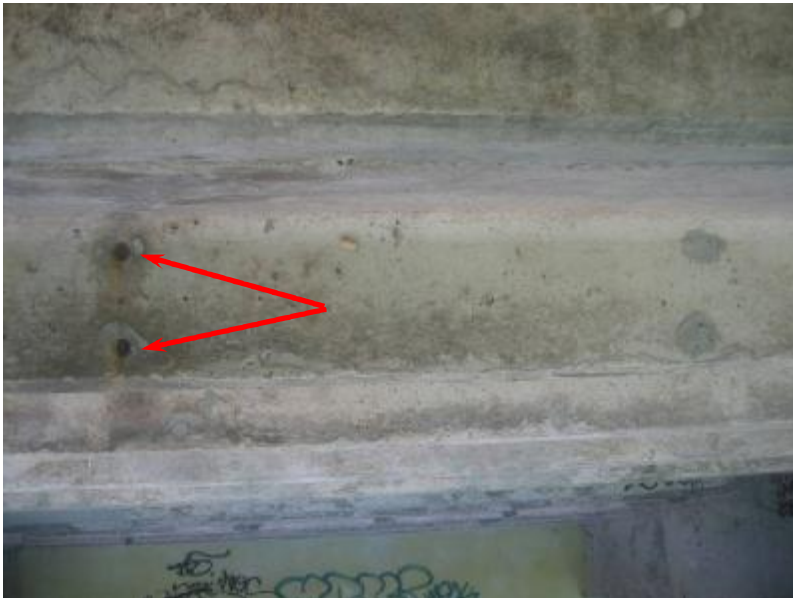
**Photo 20**

Grout plugs missing on risers.

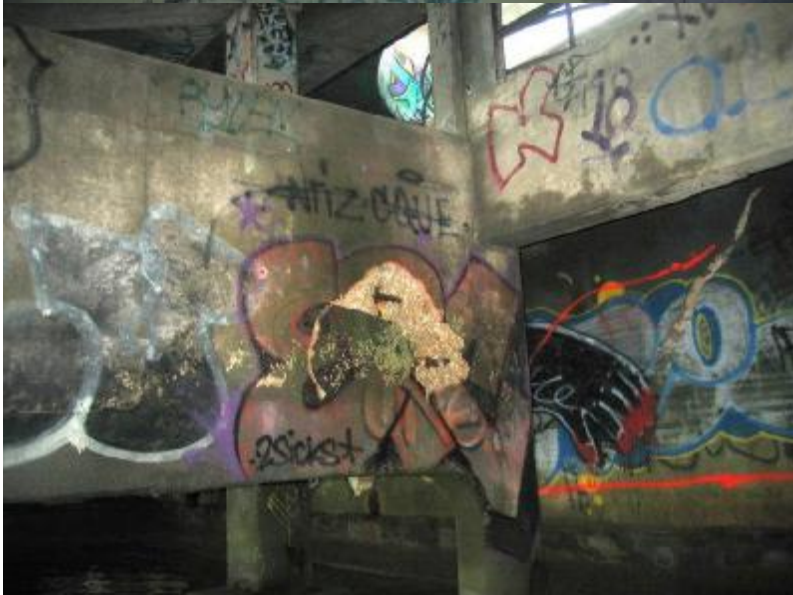
**Photo 21**

Spall on vomitory wall.

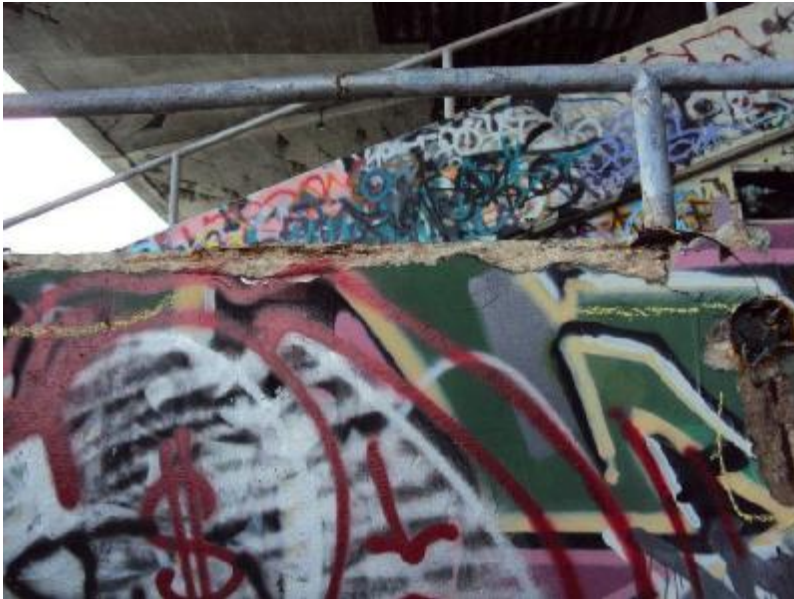
**Photo 22**

Deterioration on upper portion of parapets.

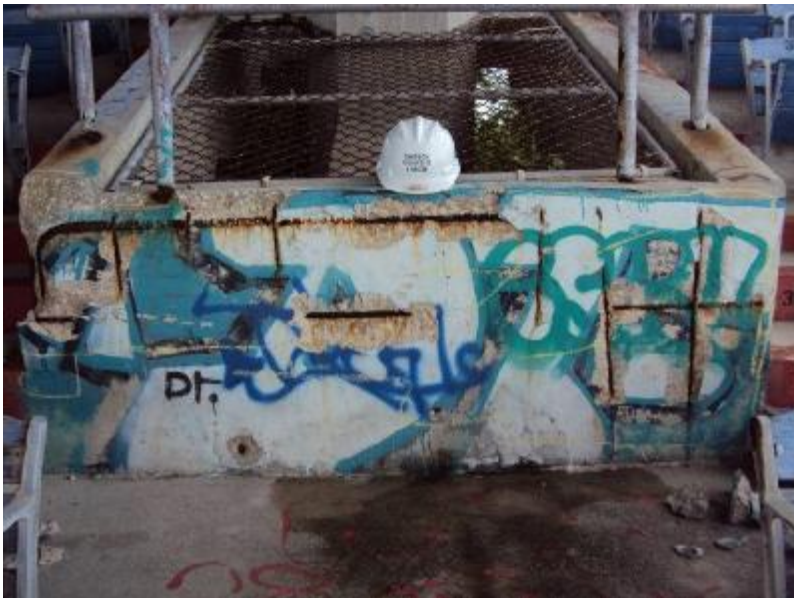
**Photo 23**

Severe deterioration on parapets around front slanted columns.

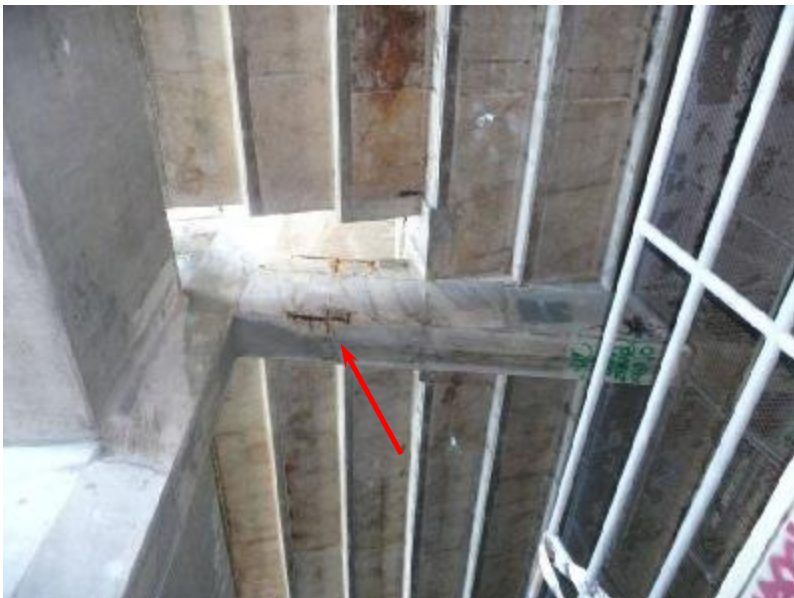
**Photo 24**

Moderate deterioration on raker beam.

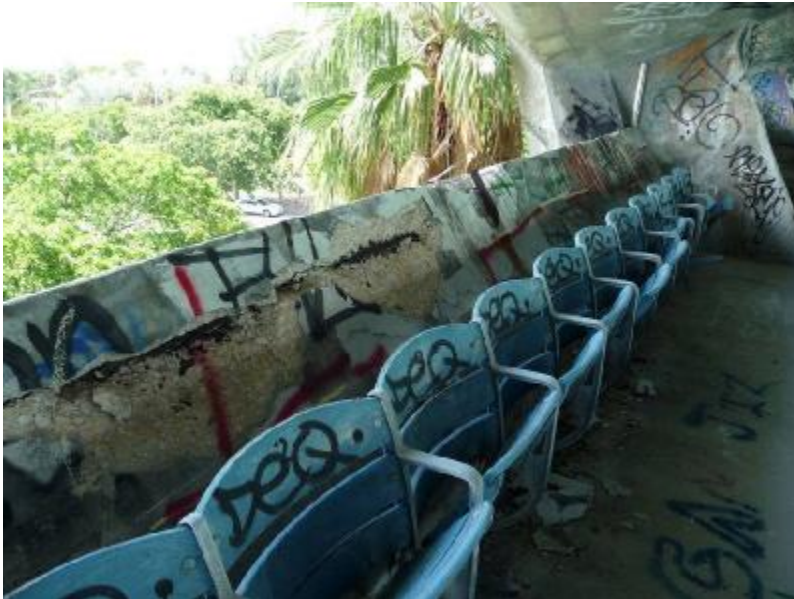
**Photo 25**

Severe deterioration on beams next to the uppermost seating row.

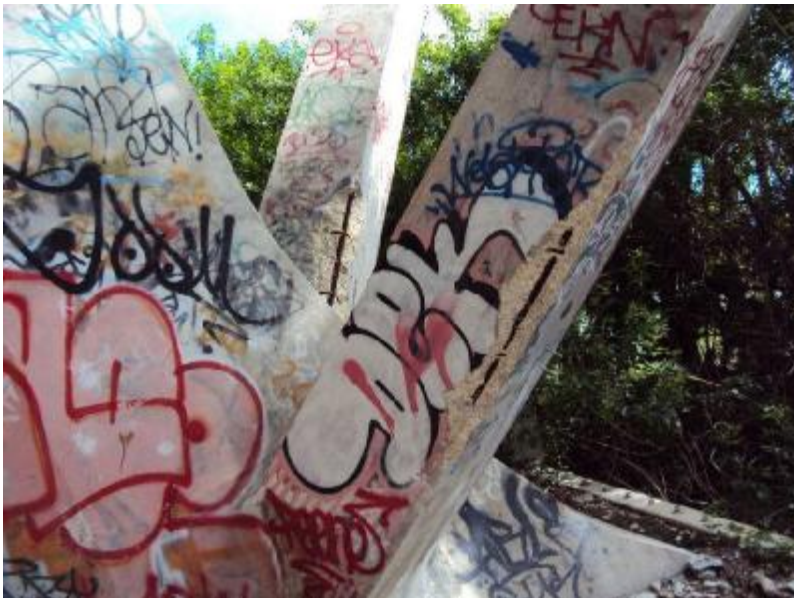
**Photo 26**

Deterioration on back slanted columns.

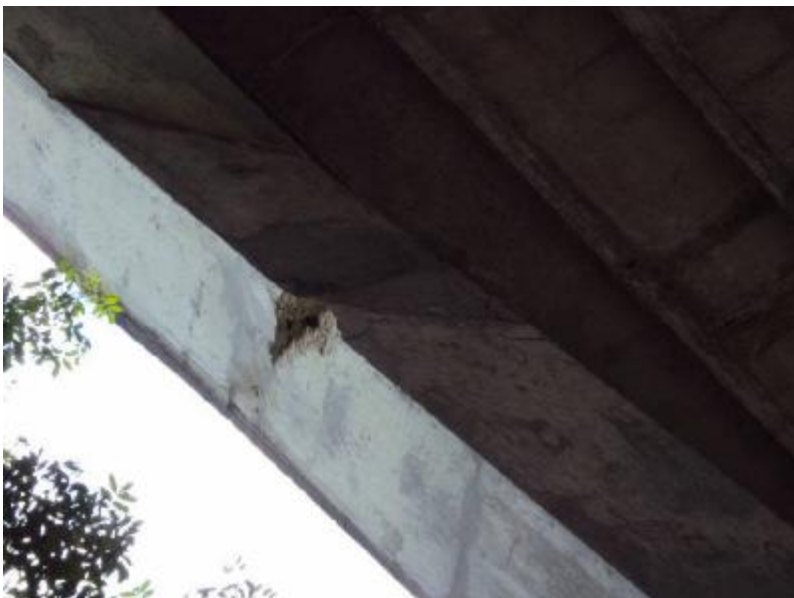
**Photo 27**

Deterioration on front slanted columns.

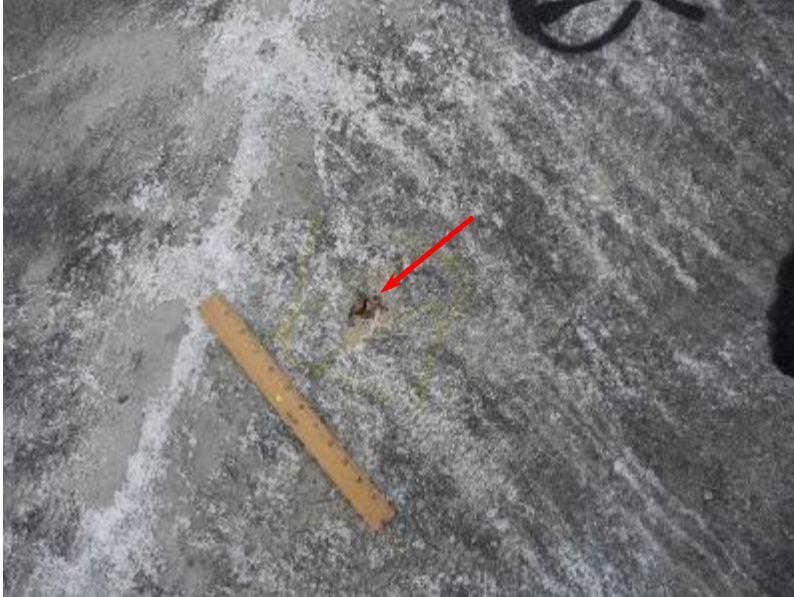
**Photo 28**

Typical spall on top side of roof hypars.

- Repair delaminated and spalled concrete on the topside and underside of the roof and wall diaphragm.
- Fill cracks in the roof by epoxy injection.

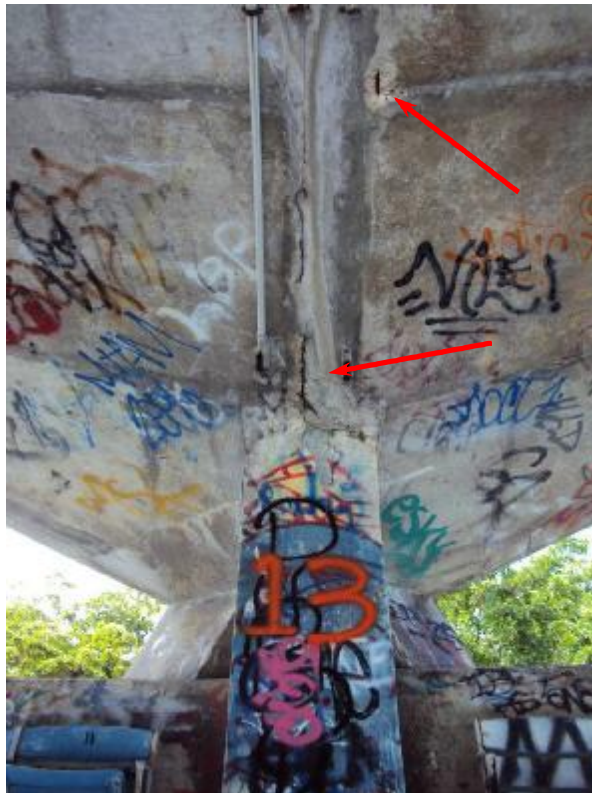
**Photo 29**

Deterioration on bottom side of roof.

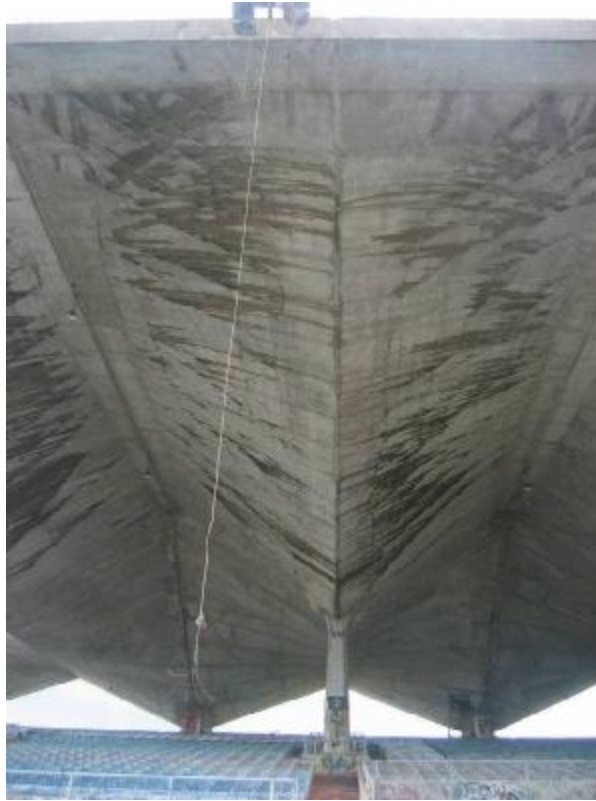
**Photo 30**

Typical cracking of roof hypars (bottom side).

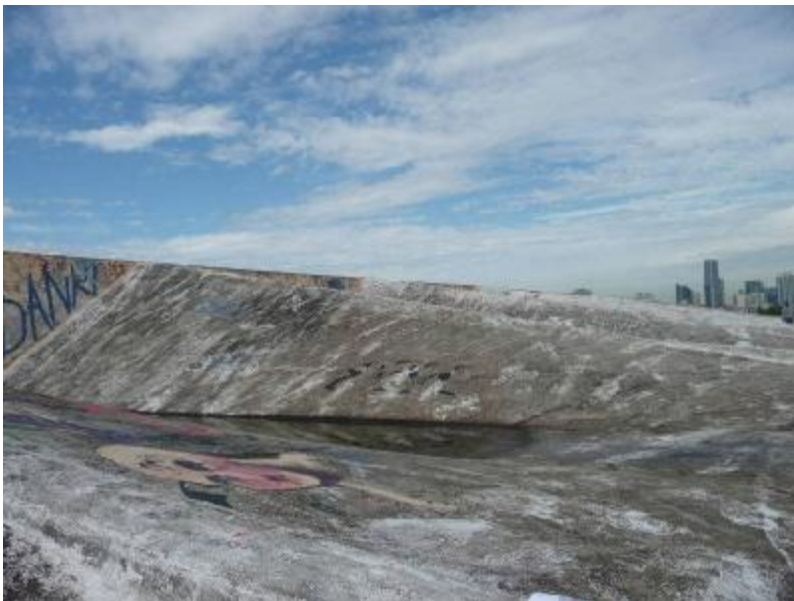
**Photo 31**

Typical cracking of roof hypars (top side).

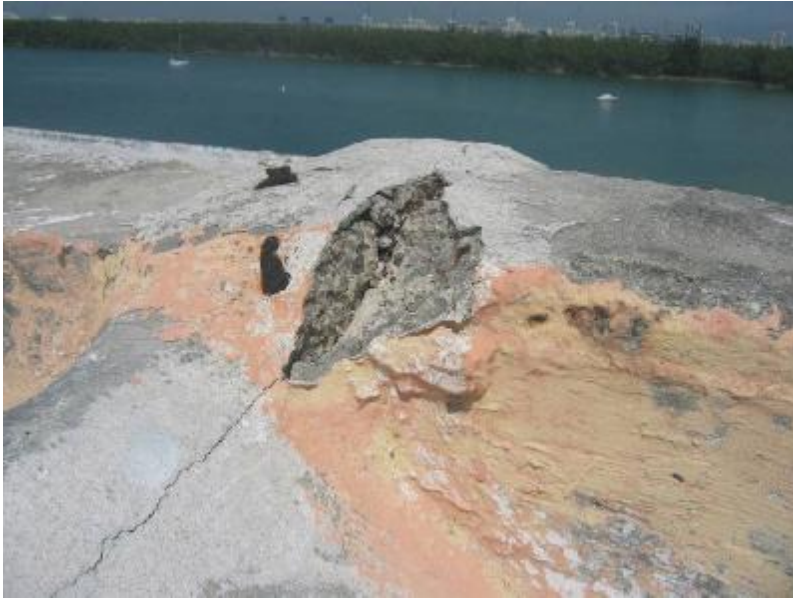
**Photo 32**

Deterioration at post-tensioning anchorage zone.

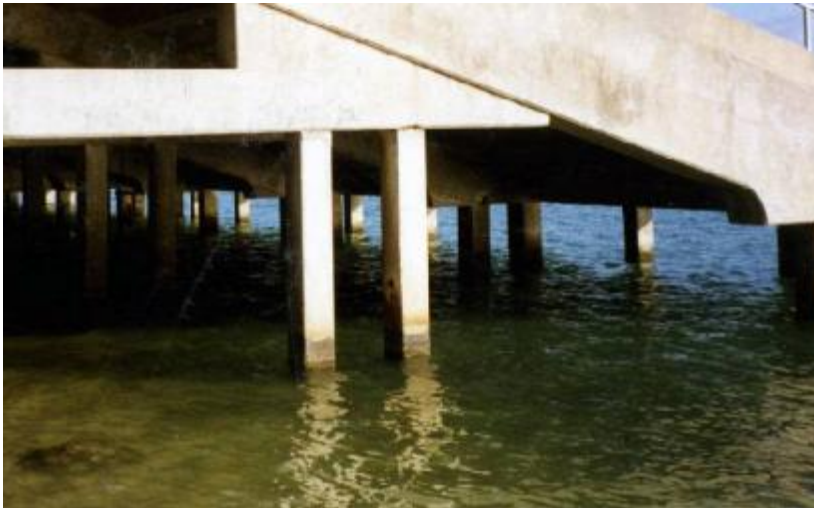
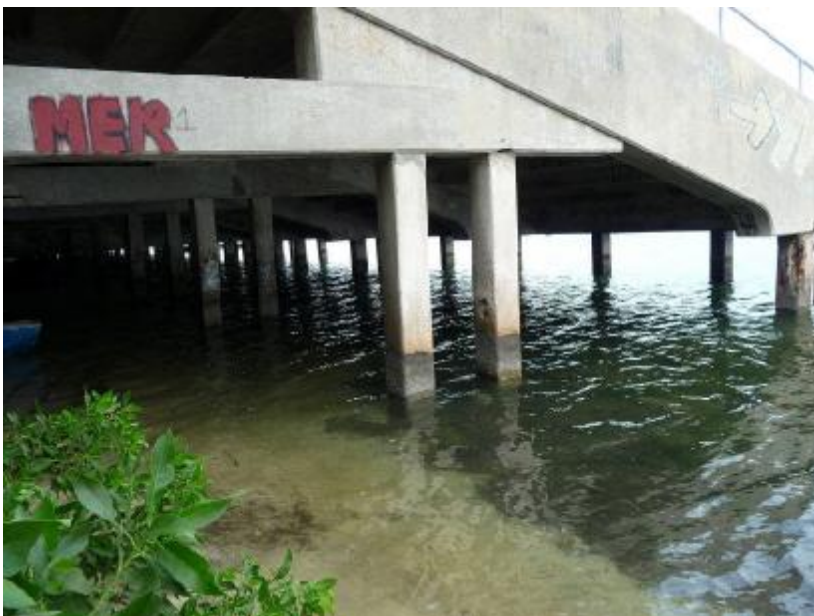
**Photo 33**

Piles F-1 and G-1 not showing significant deterioration growth.

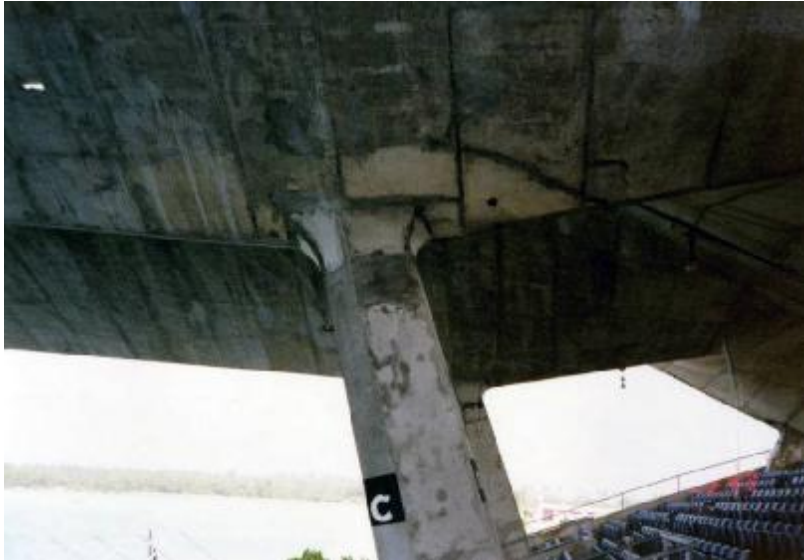
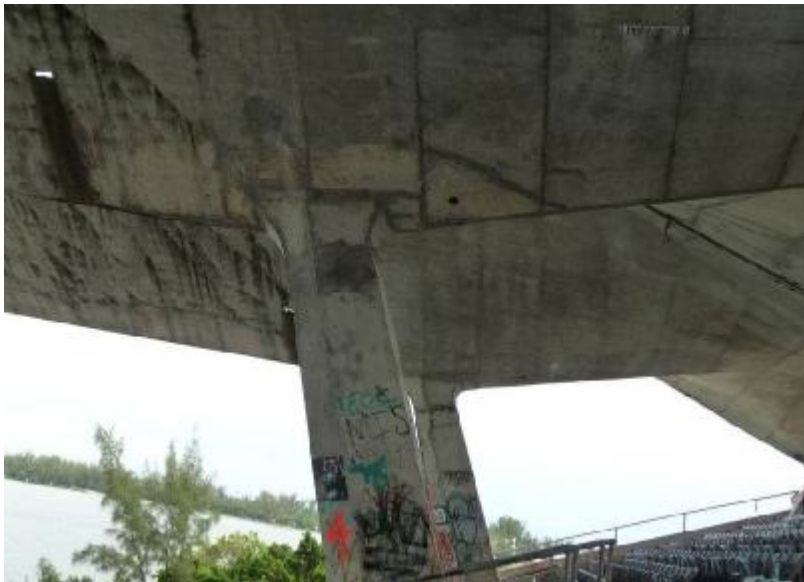
**Photo 34**

Cracking on bottom side of roof near line 4 front slanted column do not appear to have increased.

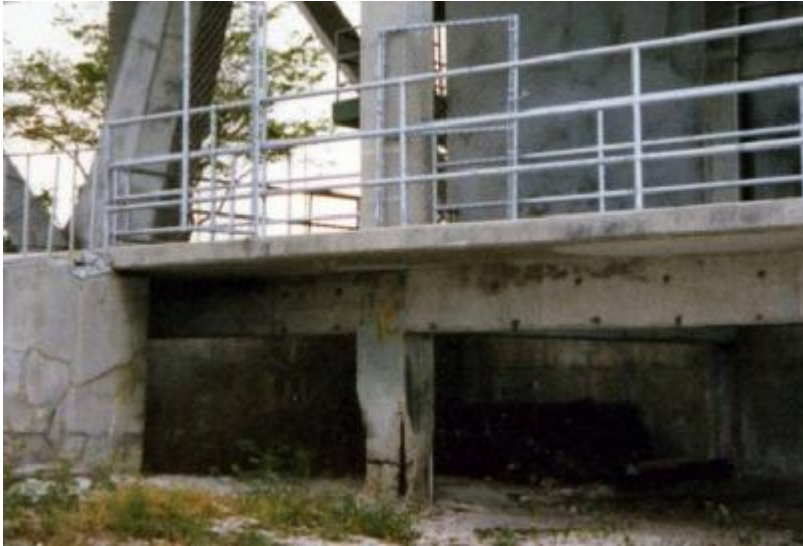
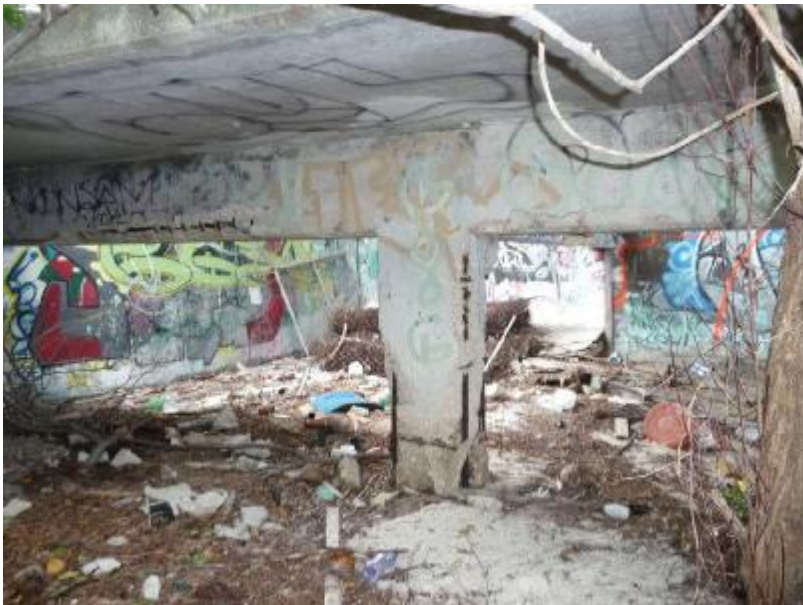
**Photo 35**

Column C-1 showing some growth of spalls.

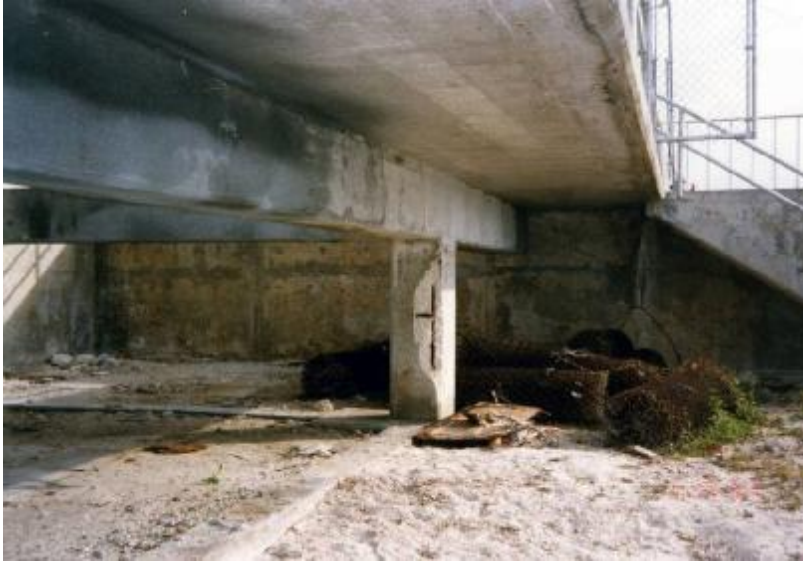
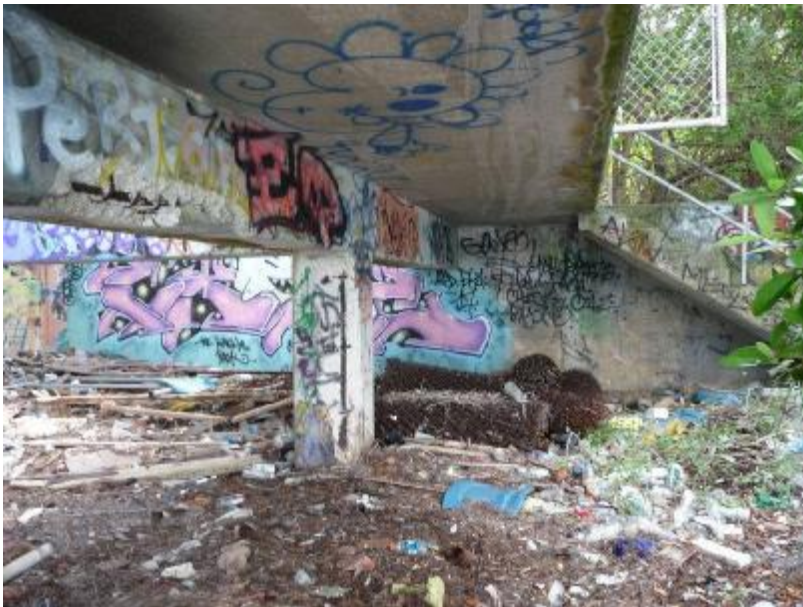
**Photo 36**

Column C-17 showing some growth of spalls.

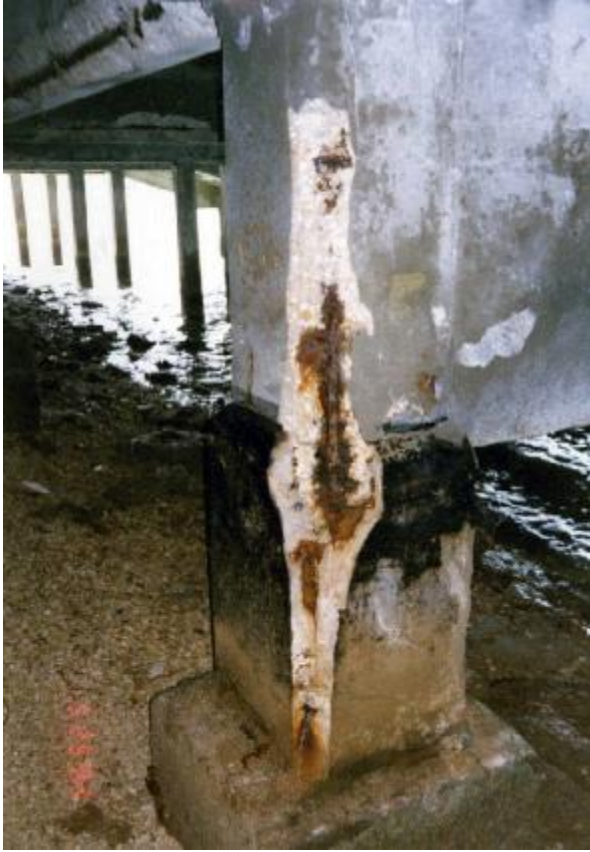
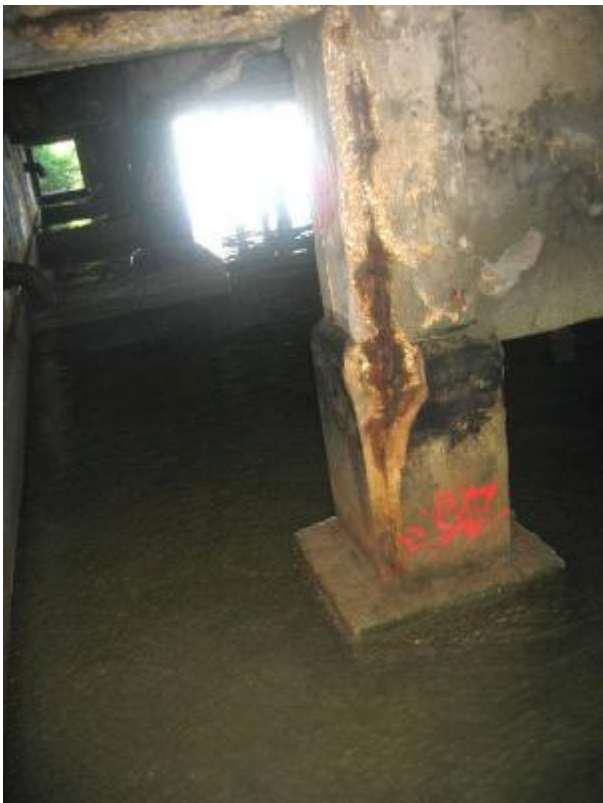
**Photo 37**

Column E-13 showing minor growth of spalls.

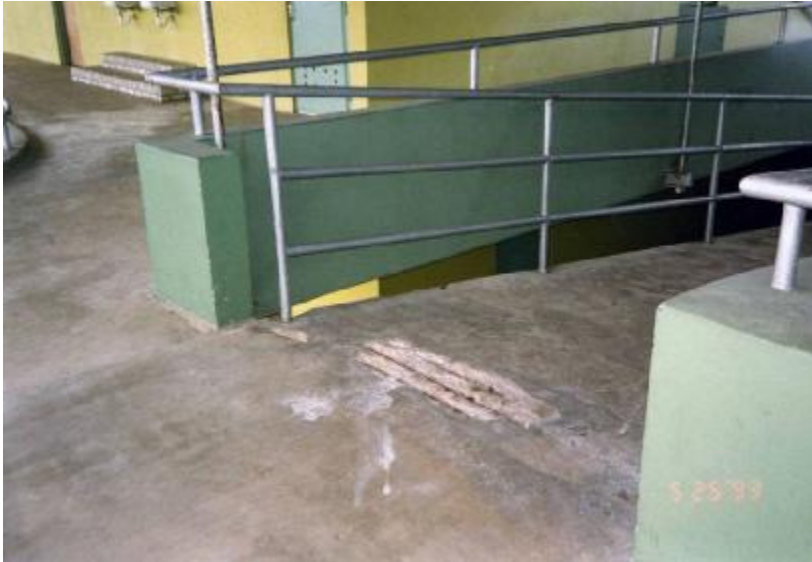
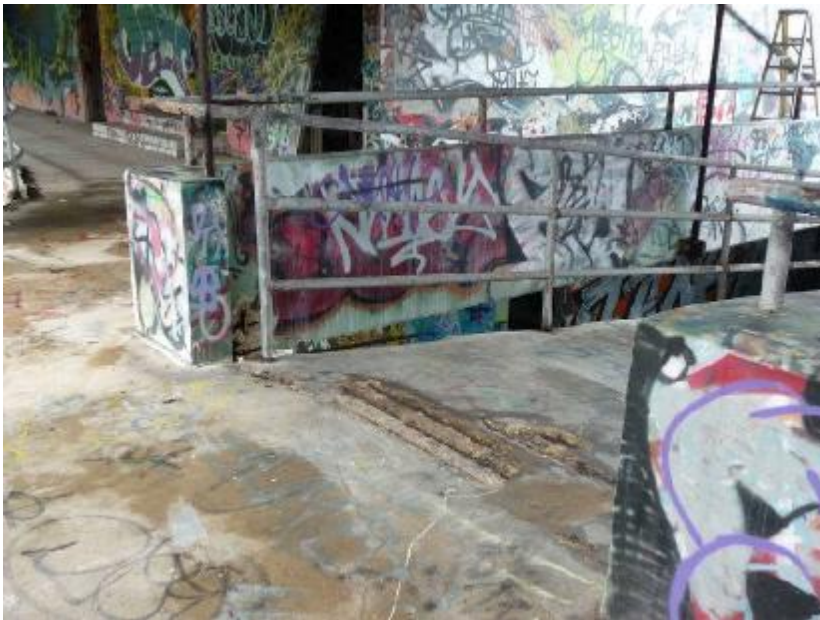
**Photo 38**

Ramp next to column line 5 showing some growth of spalls.

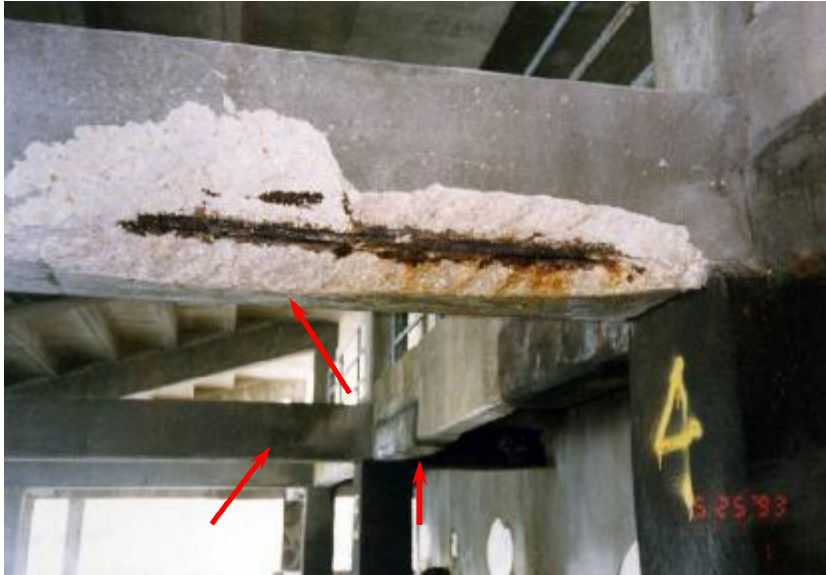
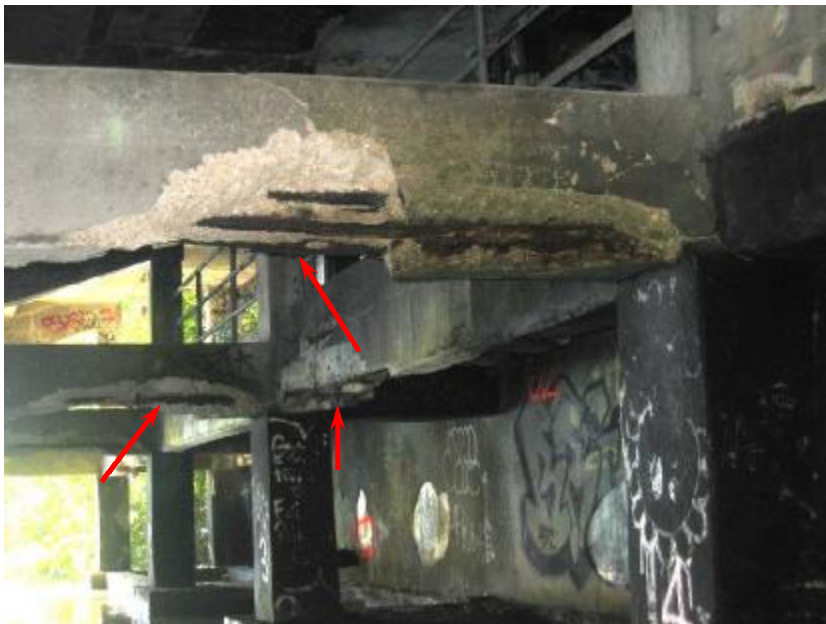
**Photo 39**

Beams over water showing growth of spalls and new spalls.
