Structural Repair  
and Protection  
Cost Estimate  
and Attendant  
Condition  
Appraisal of the  
Miami Marine  
Stadium

Miami, FL  
January 2010

SGH Project 090457

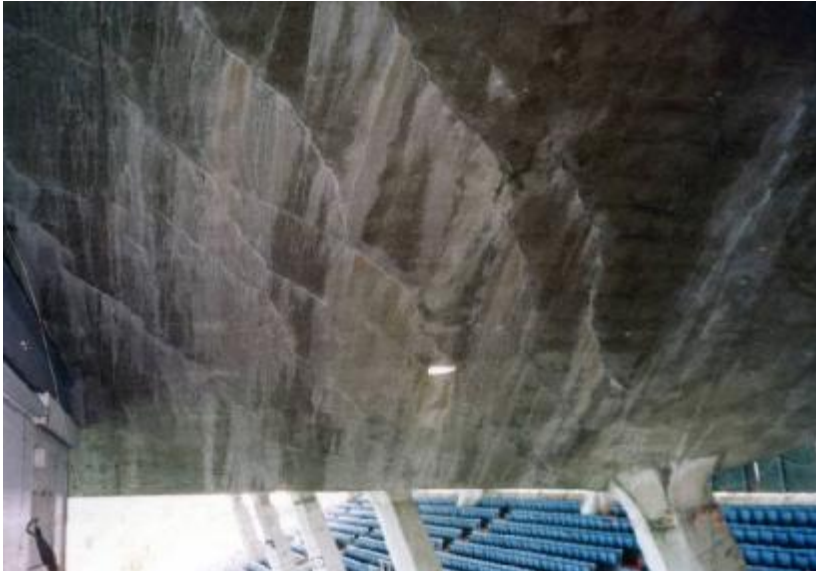
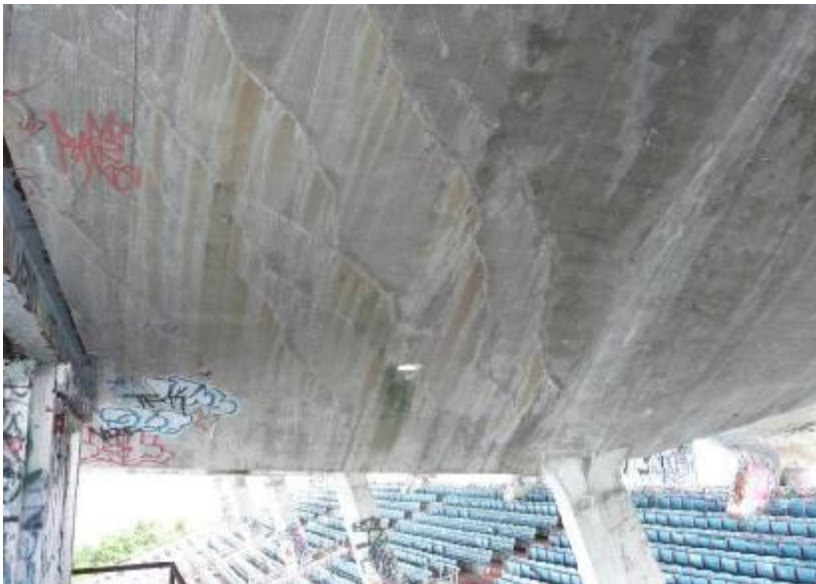
**Photo 40**

Cracking on bottom side of roof near line 12 front slanted column do not appear to have increased.
