Condition Appraisal and Structural Review
Miami Marine Stadium Roof Structure
Miami, Florida

Volume I - Report

The Hartford Steam Boiler
Inspection and Insurance Co.
One State Street
Hartford, Connecticut 06102

Simpson Gumpertz & Heger Inc.
297 Broadway
Arlington, Massachusetts 02174
Tel: 617 643-2000
Fax: 617 643-2009

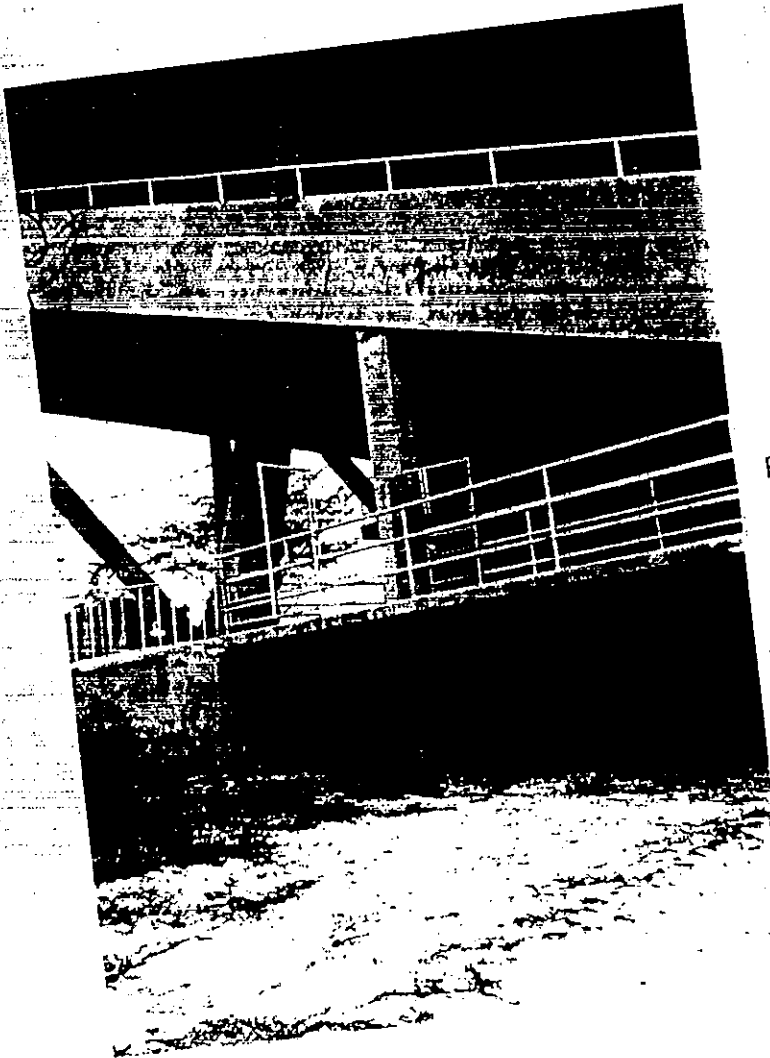
Photo 53

- Severe corrosion of reinforcing steel and associated concrete spalling in columns at Column Locations C-1 (Photos 53 and 54) and C-17 (Photo 55) and in a pier along Column Line E (Photo 56).

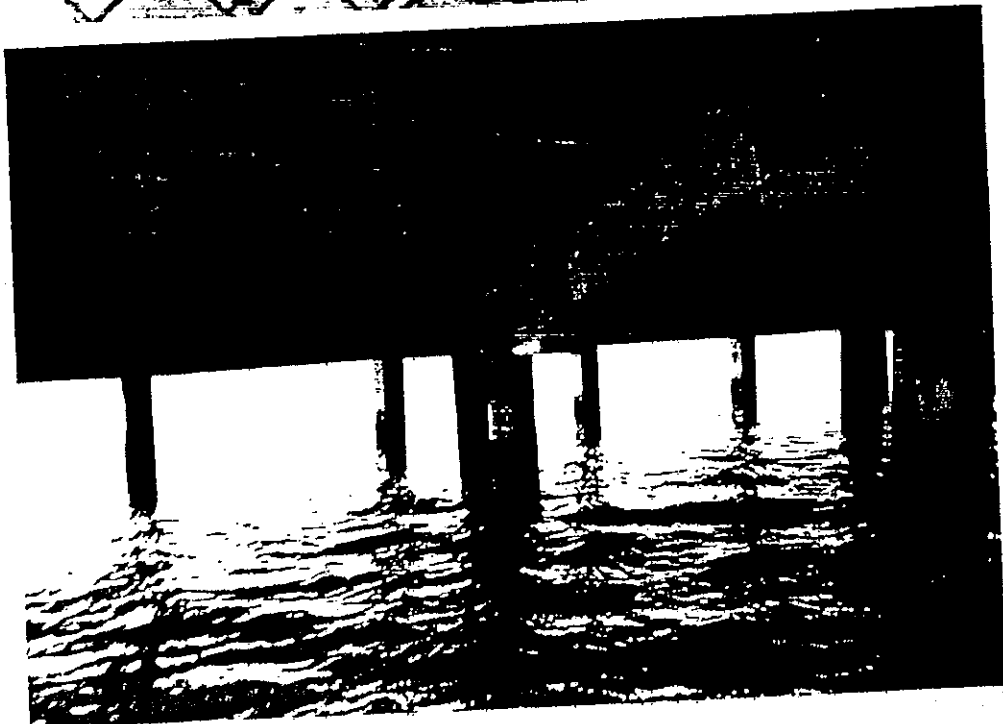
Photo 66

Many of the piles and tie beams in the over-water section of the structure have been previously repaired (Photos 66 and 67). Examination of one previous tie beam repair (Photos 68 and 69) indicates that the repair did not include the concrete around the corroding reinforcing steel.
