**City of Miami
Marine Stadium
At
Virginia Key**

Existing Building Condition Assessment

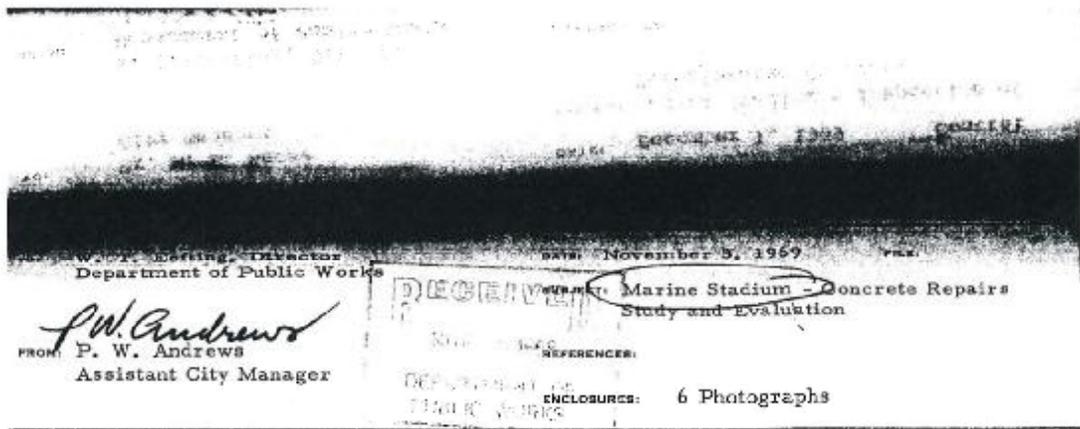
Mr. Lee Evans, director of the Marine Stadium, submitted the attached photographs which indicate that there are some serious problems occurring with relation to concrete spalling.

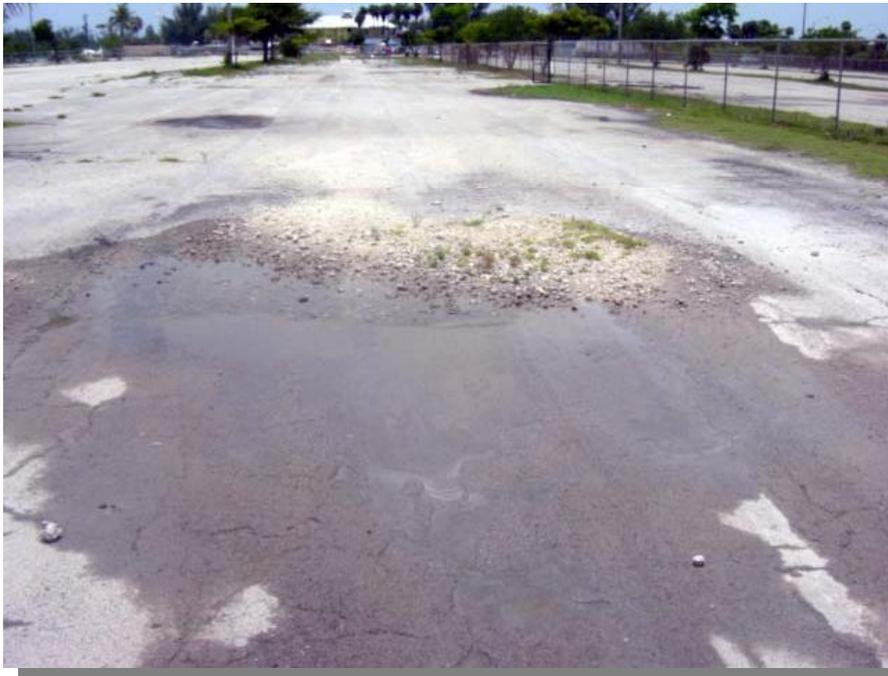
2- Parking Area Paving Deterioration

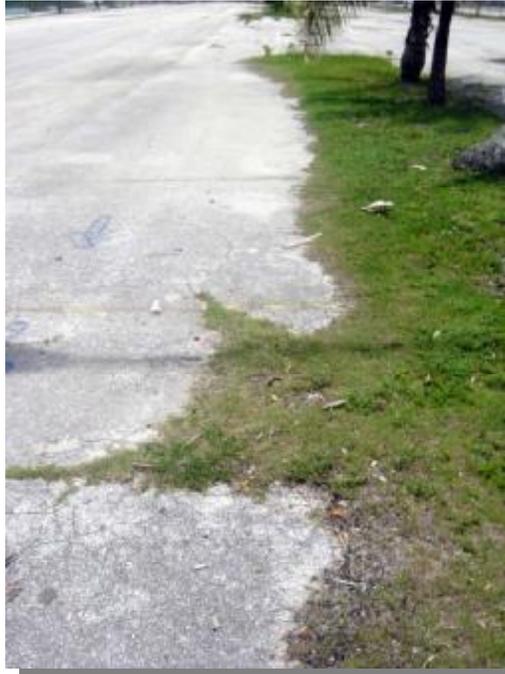
3- Landscape Area Encroaching Into Parking Area

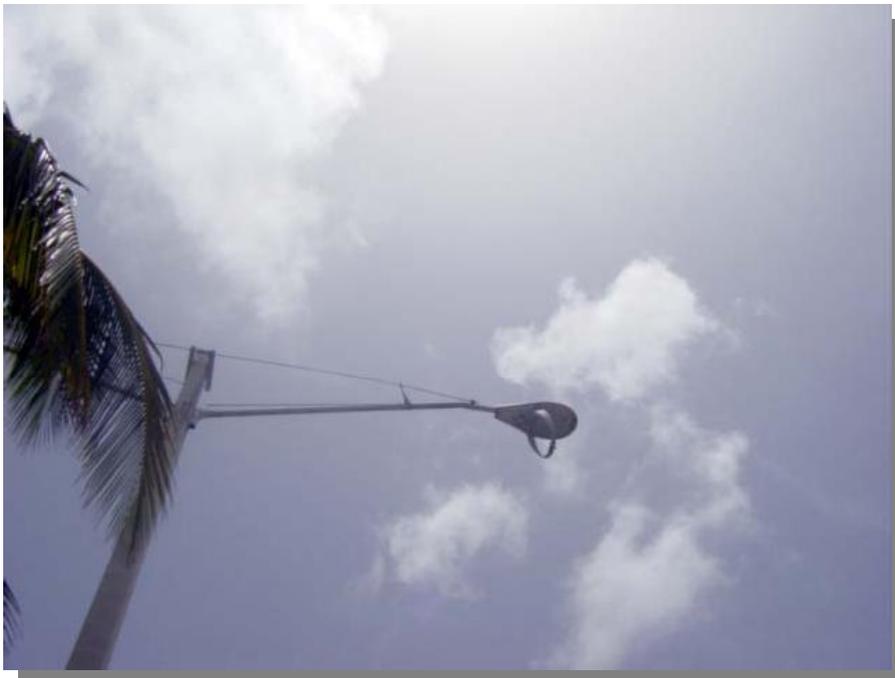
4- Site Lighting Typical Condition

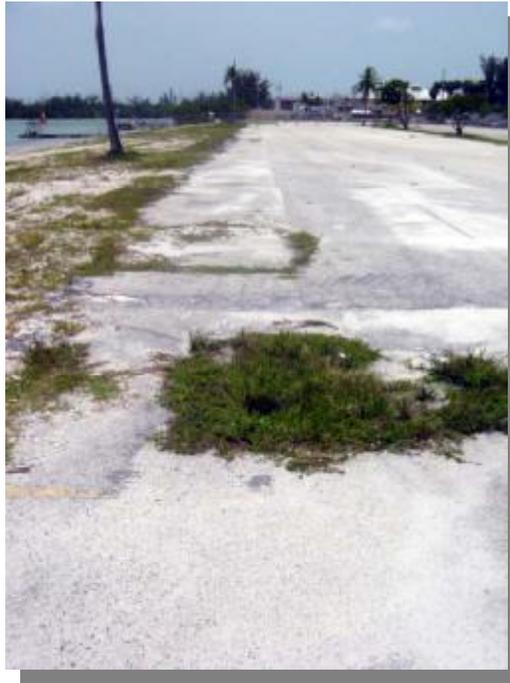
5- Parking Area Deterioration

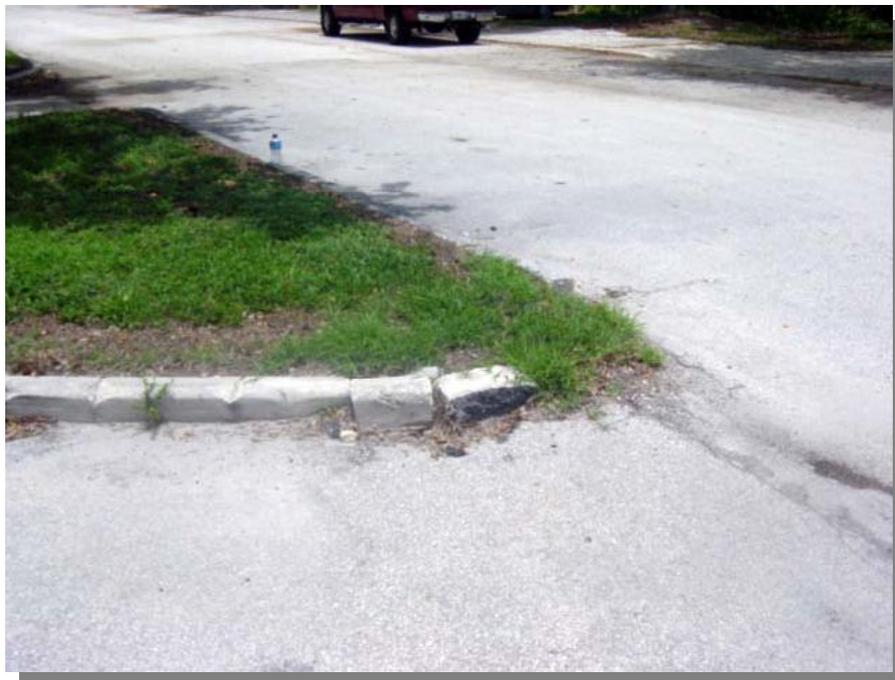
6- Typical Condition of Site Curbing

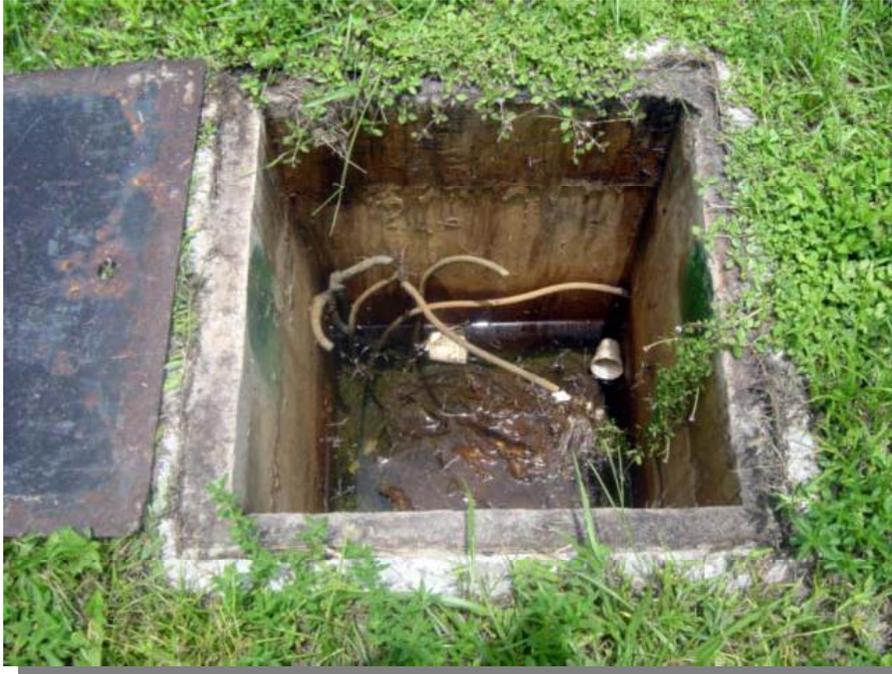
7- Equipment Box Equipment Stolen

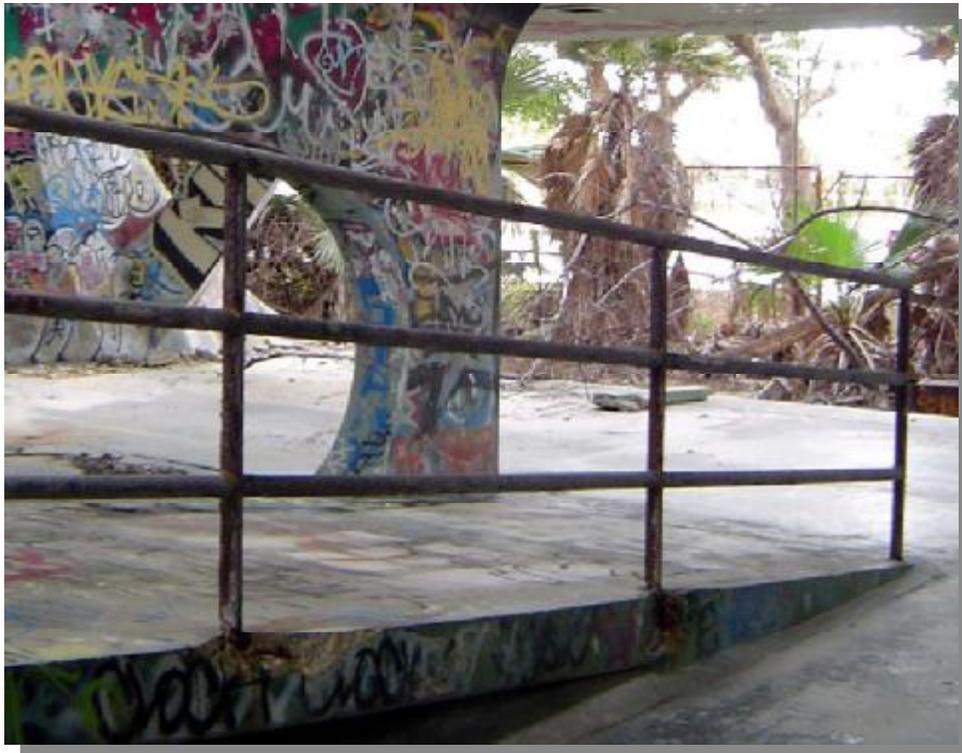
12- Railing and Imbed Condition

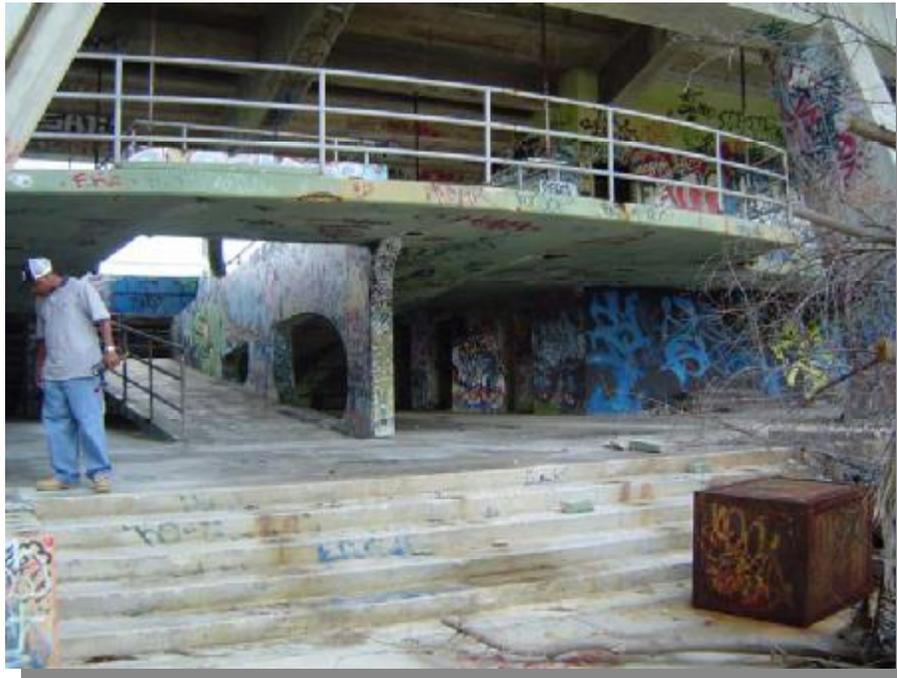
13- Typical Building Entry Access

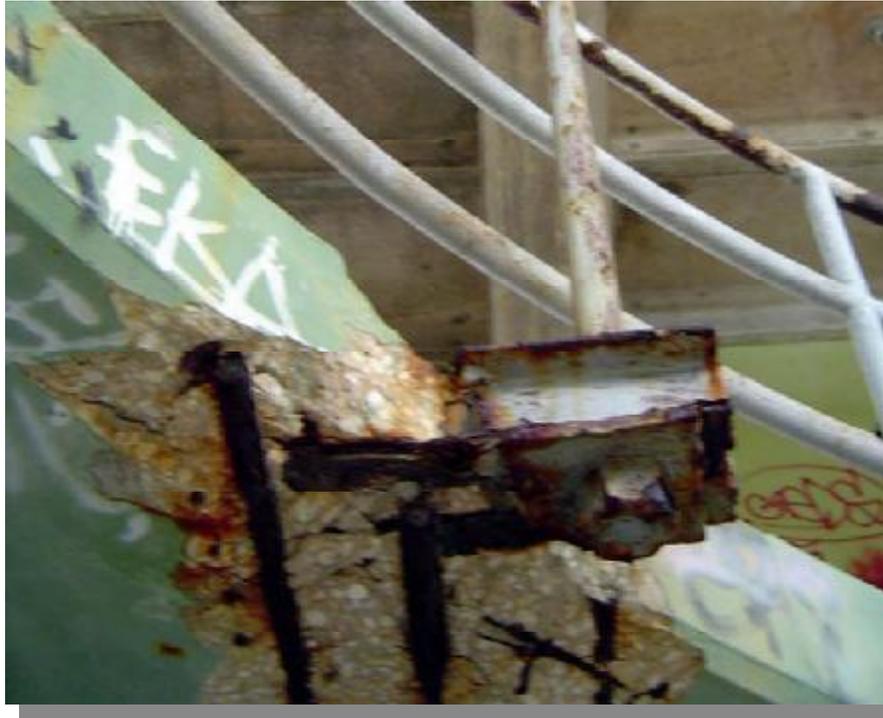
14- Ramp Access at Ground Level – No Guardrails and Handrails

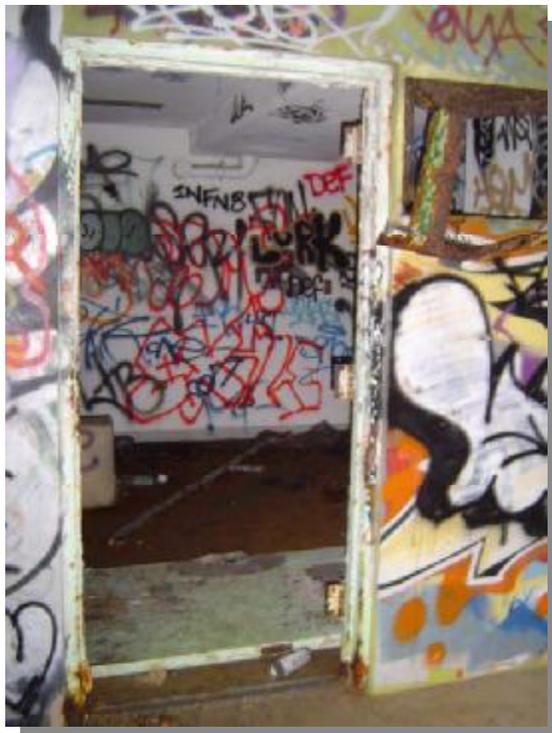
16- Typical Building Condition

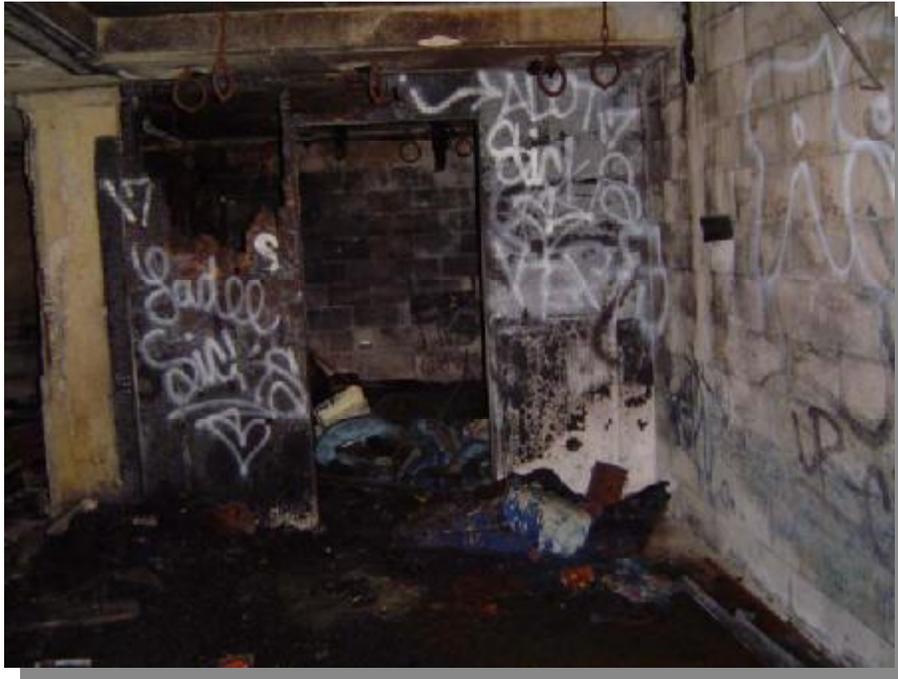
17- Typical Building Condition

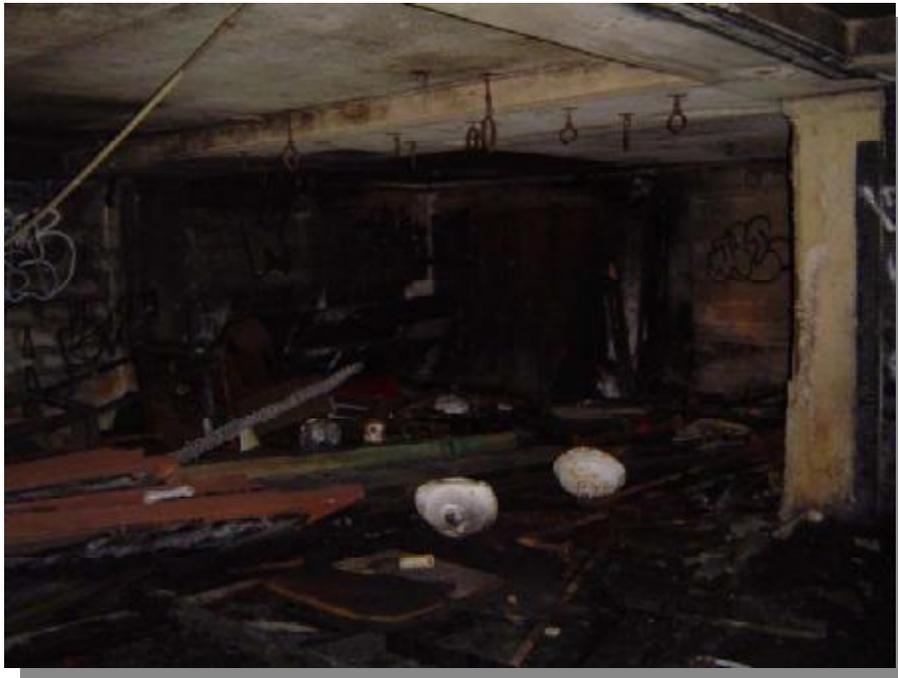
18- Area with Fire Damage

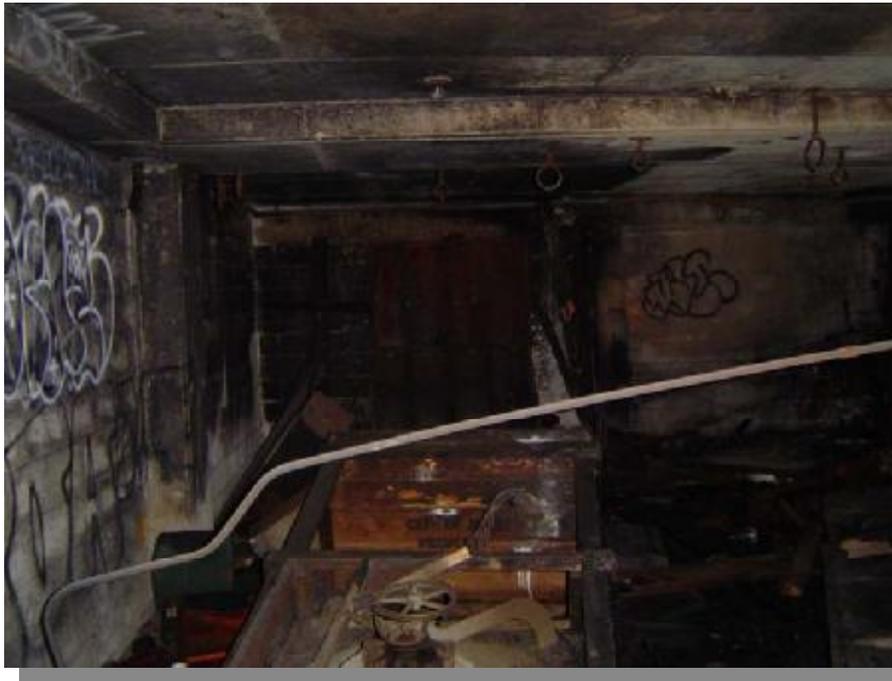
19- Area with Fire Damage

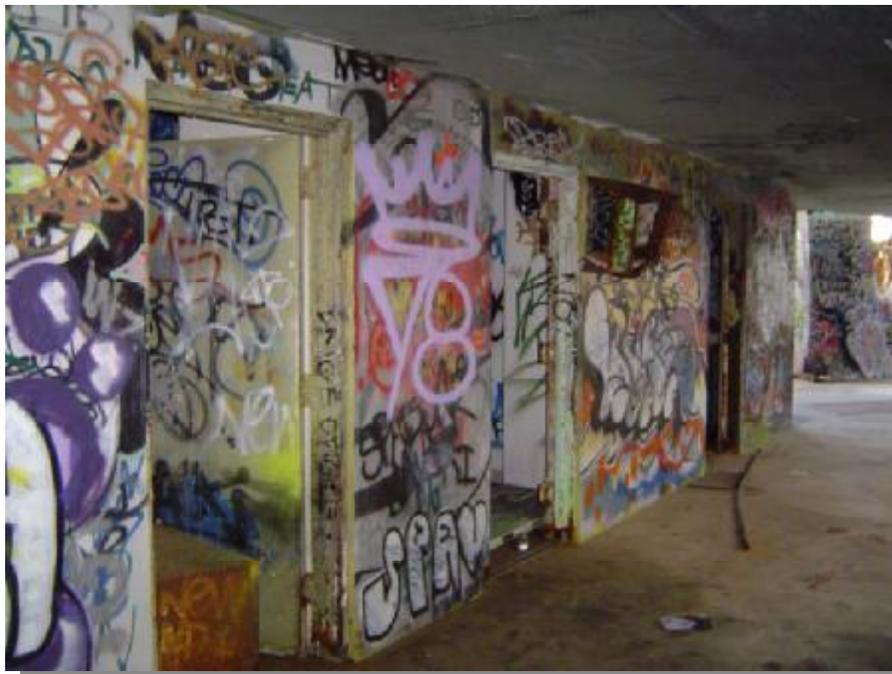
20- Typical Building Condition

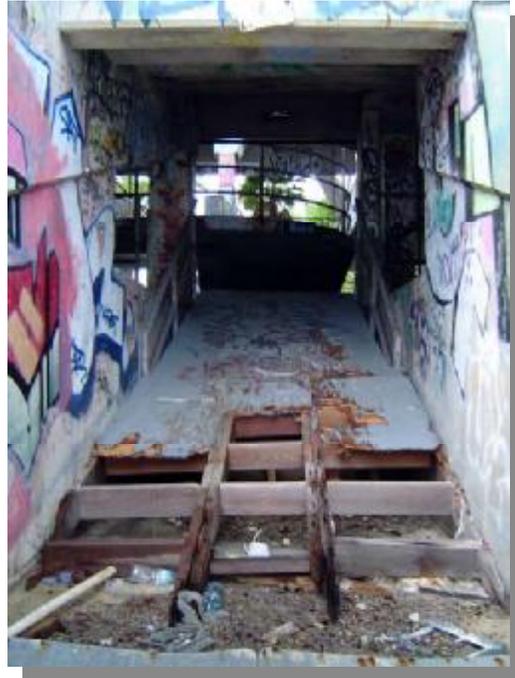
21- Ramp to Lower Level

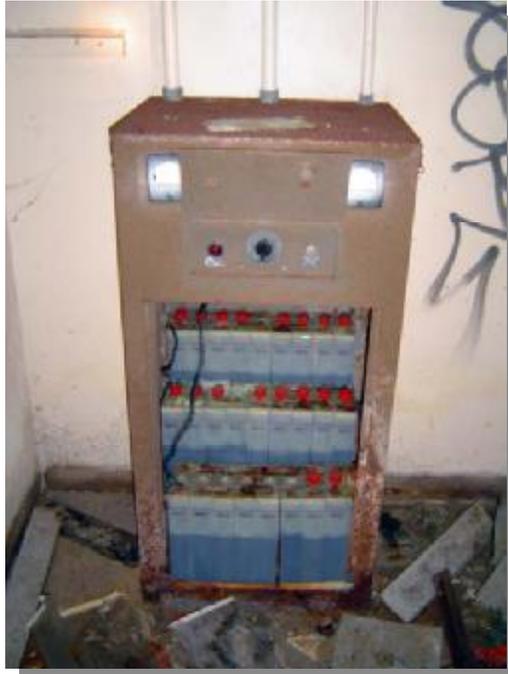
25- Hazardous Material Battery Back Up System

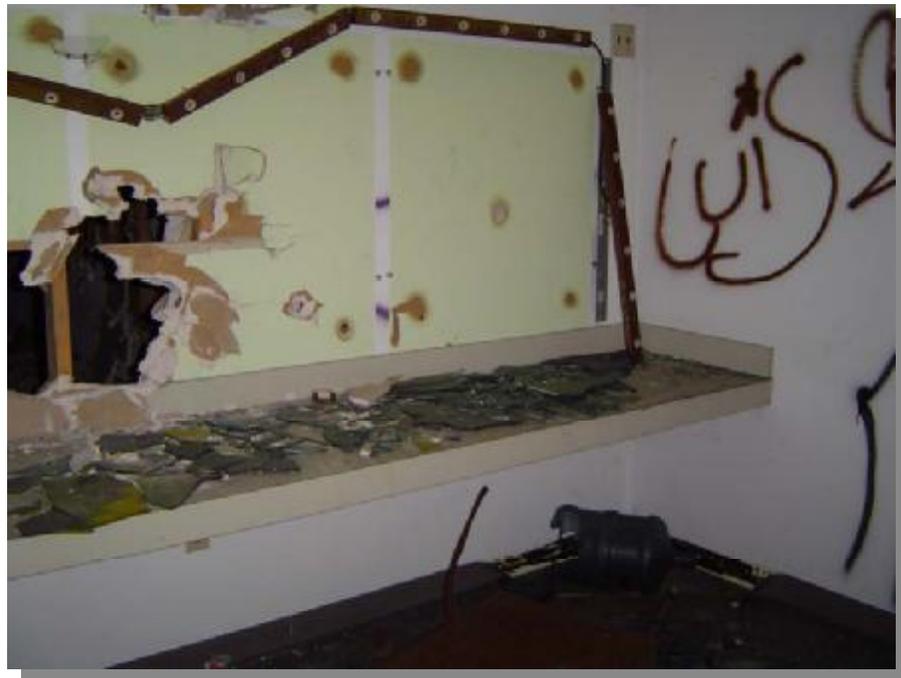
26- Dressing Room Area General Building Condition

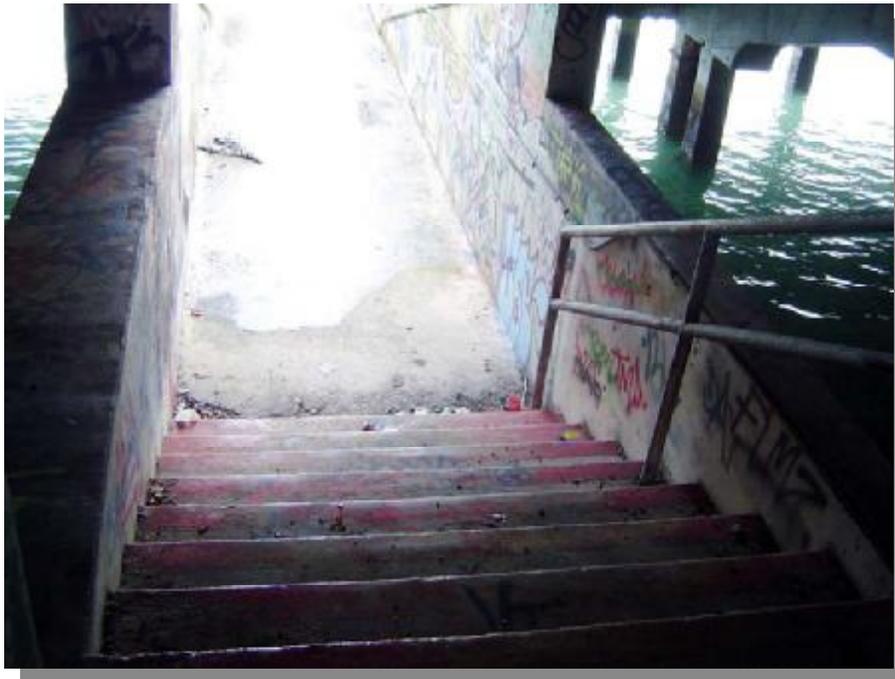
27- Lower Level Seating Access

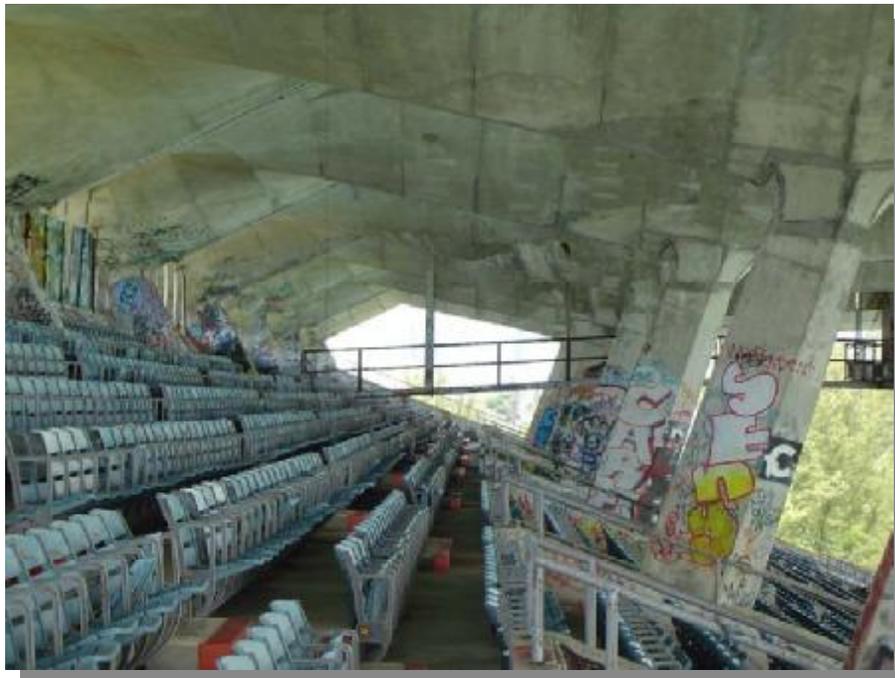
30- Typical Condition Grand Stand Seating Area

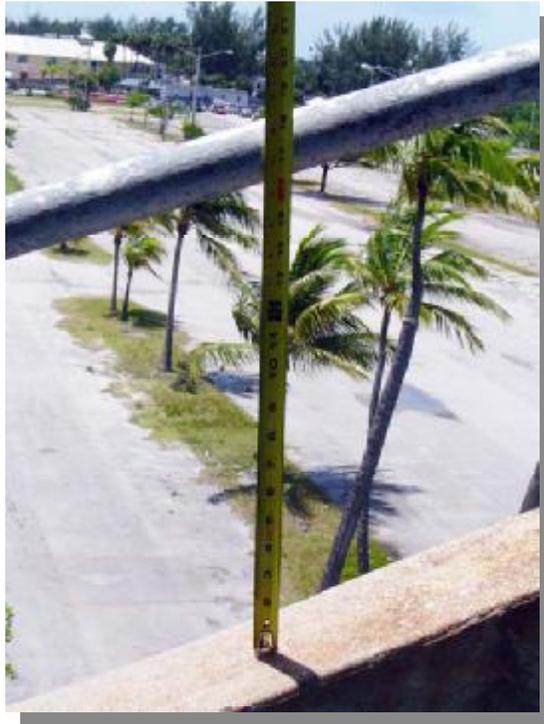
31- Railing Spacing at Grand Stand Seating Area

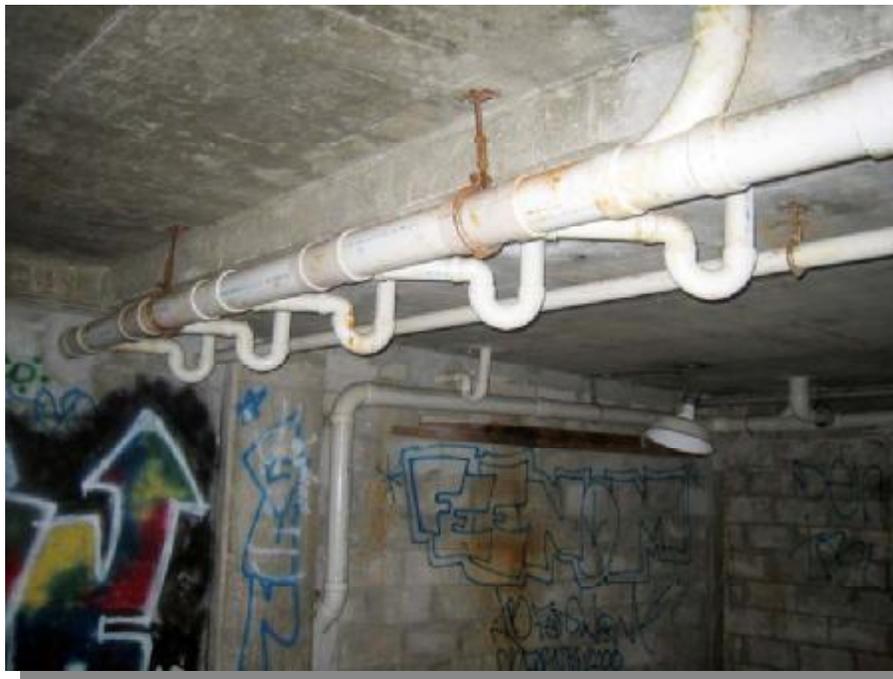
34- Sanitary Piping PVC Retro Fit and Missing Pipe Supports

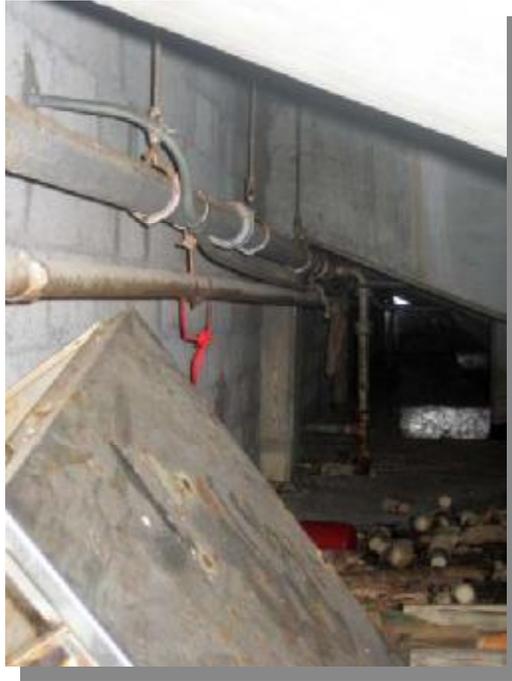
35- Air Handling Units in Crawl Space

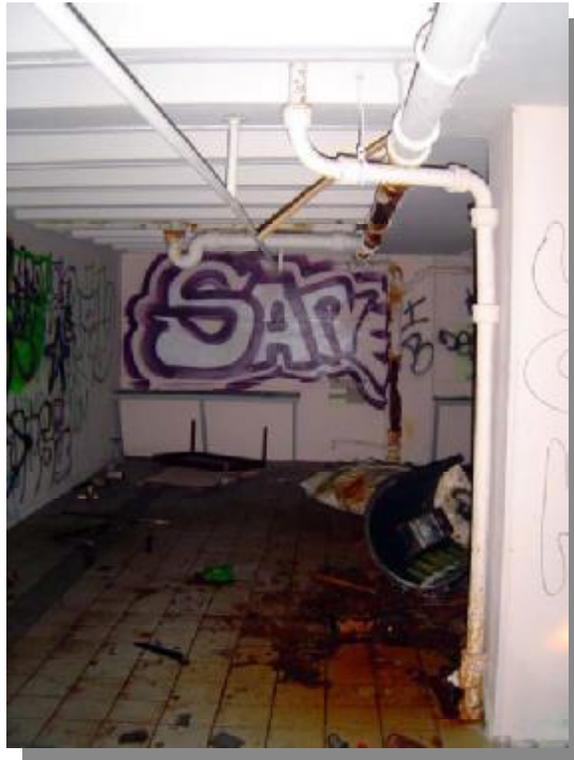
37- Cast Iron Sanitary Line Deterioration

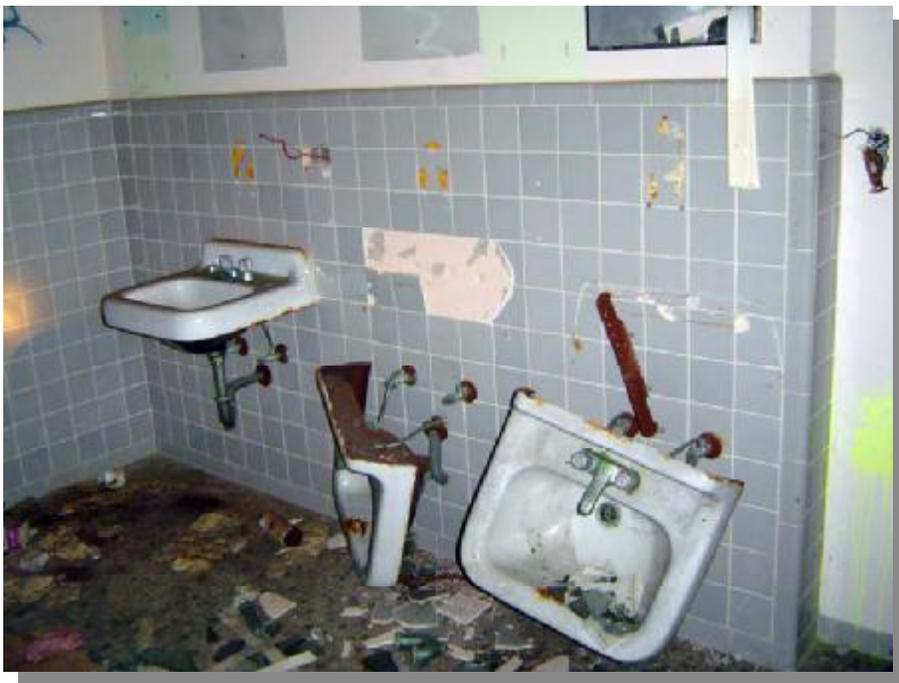
38- Plumbing Fixture Damage

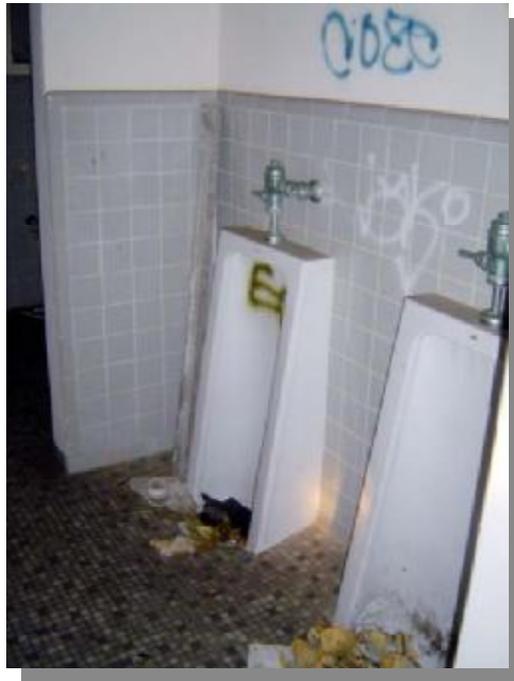
39- Plumbing Fixtures with Debris

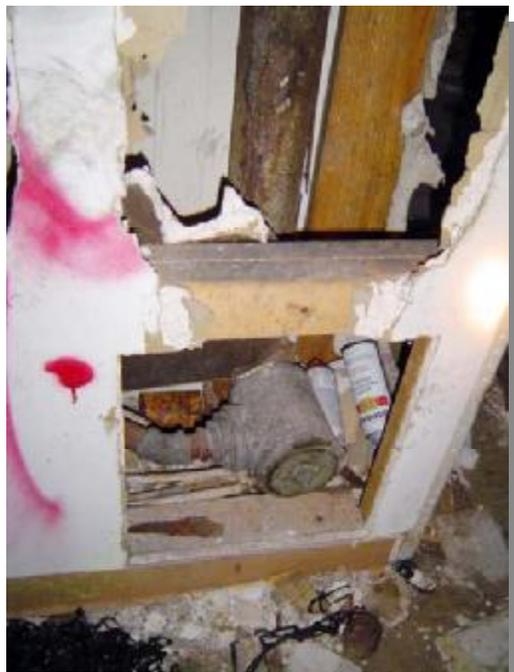
40- Cast Iron Sanitary Piping Deterioration

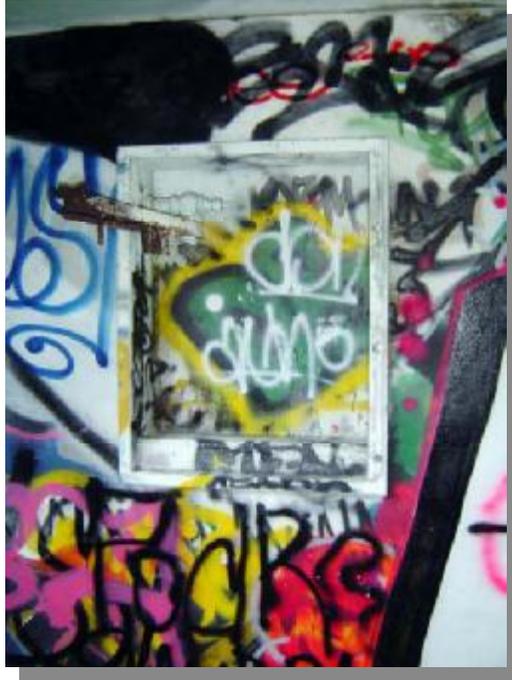
41- Disassembled Fire Hose Cabinet

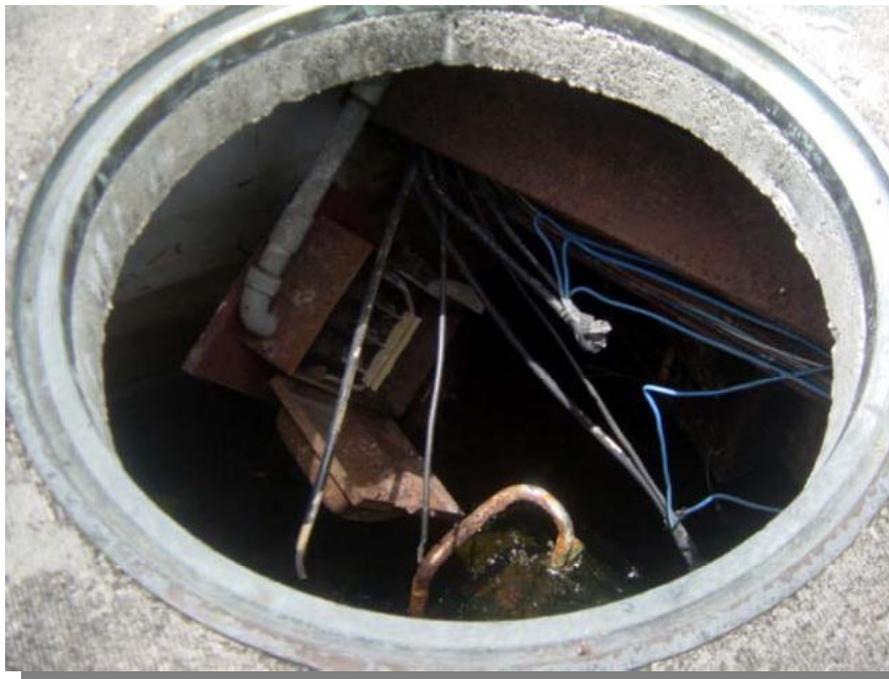
50- Lift Station Equipment Damage

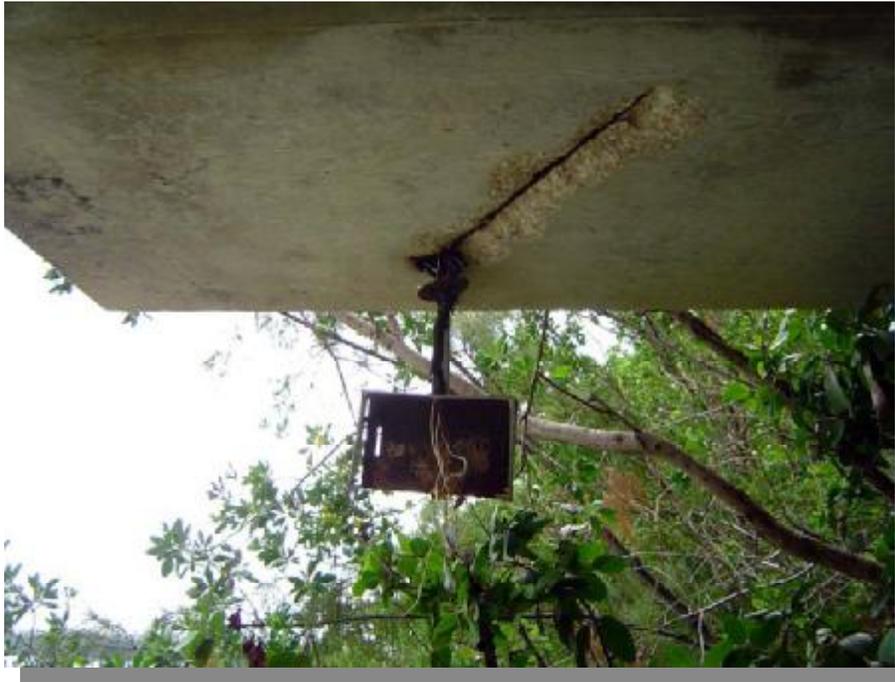
51- Conduit and Fixture Deterioration

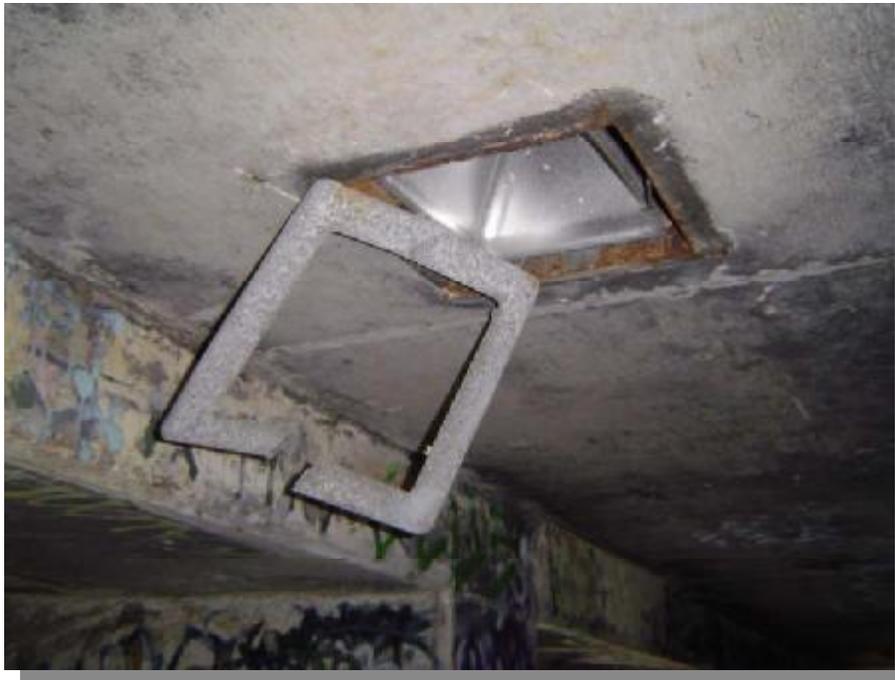
52- Fixture Deterioration

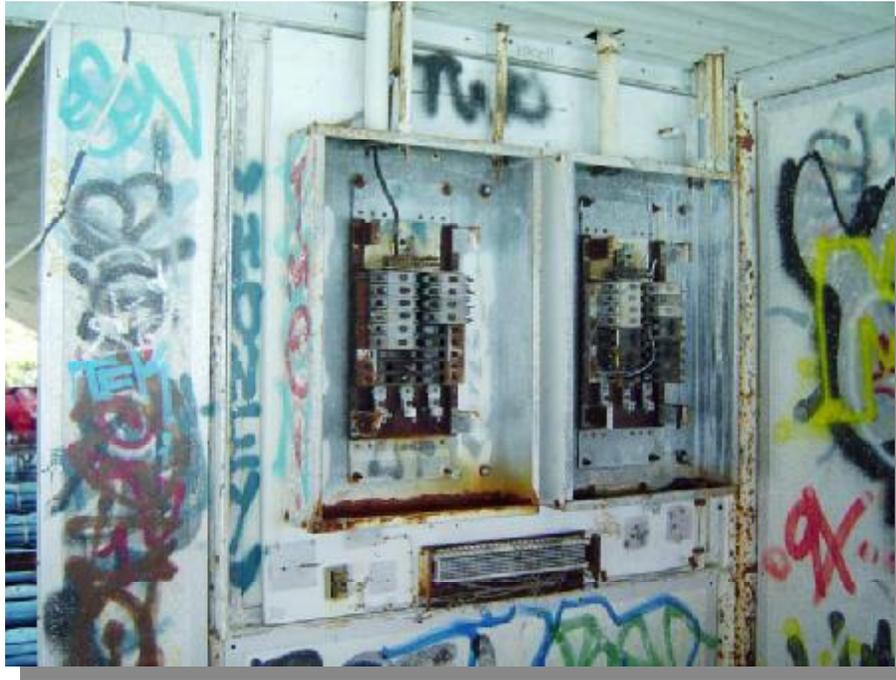
57- Disassembled and Deteriorated Electrical Panels

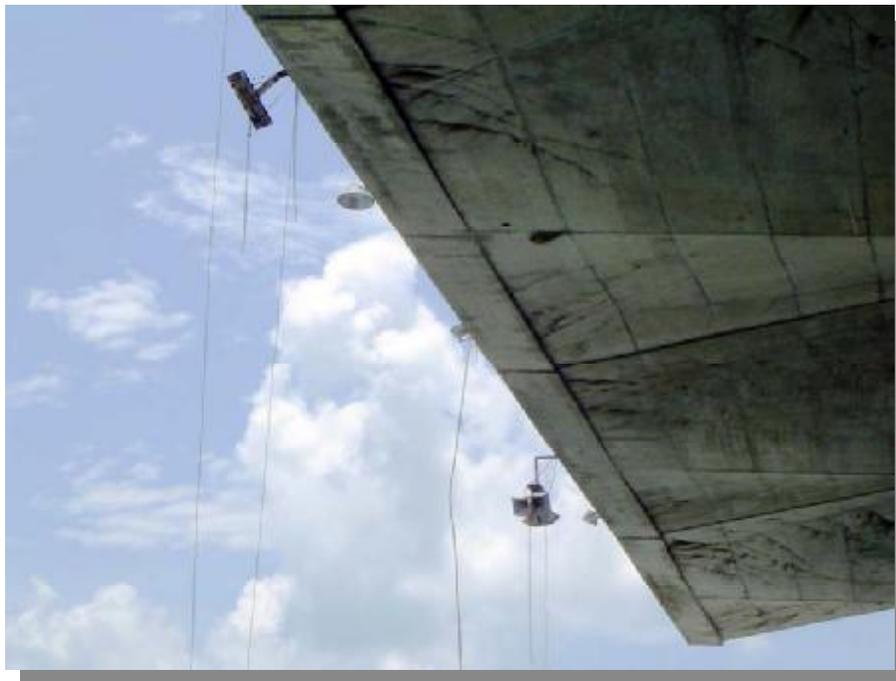
58- Lighting and Sound System Typical Condition

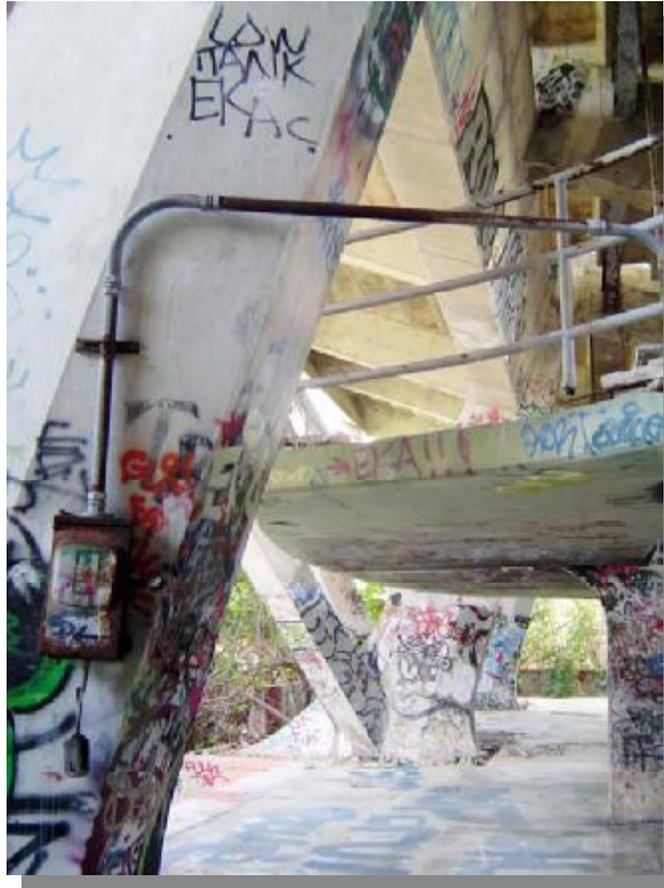
59- Electrical Disconnect Typical Deterioration

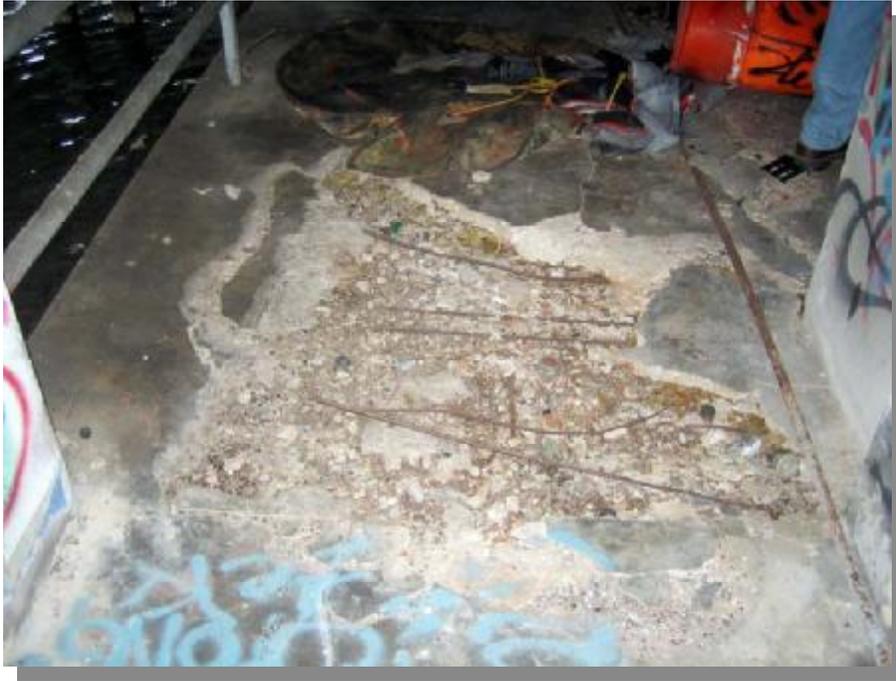
60- Lower Level Walkway Slab Deterioration

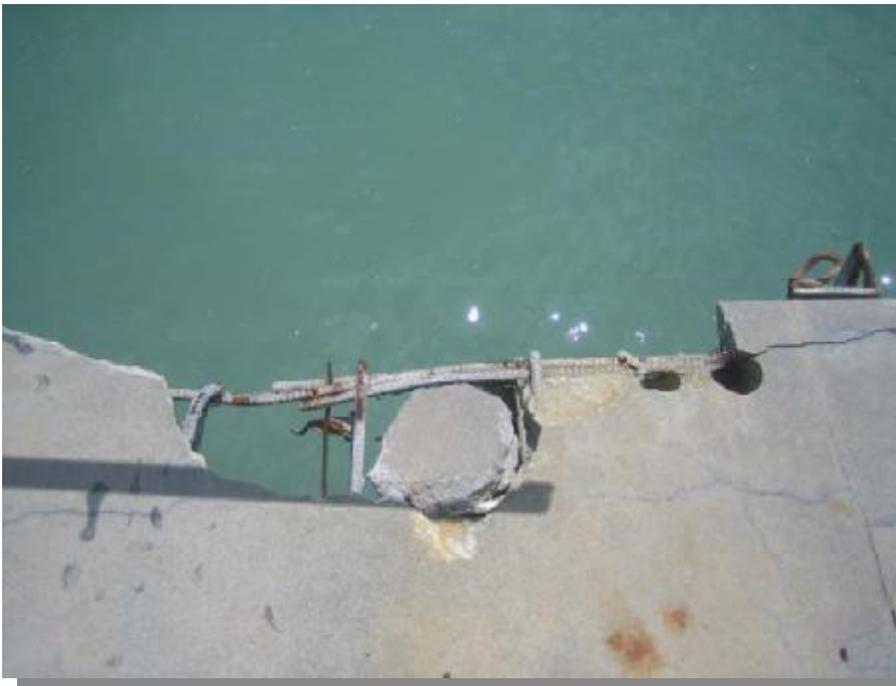
61- Lower Level Slab Deterioration

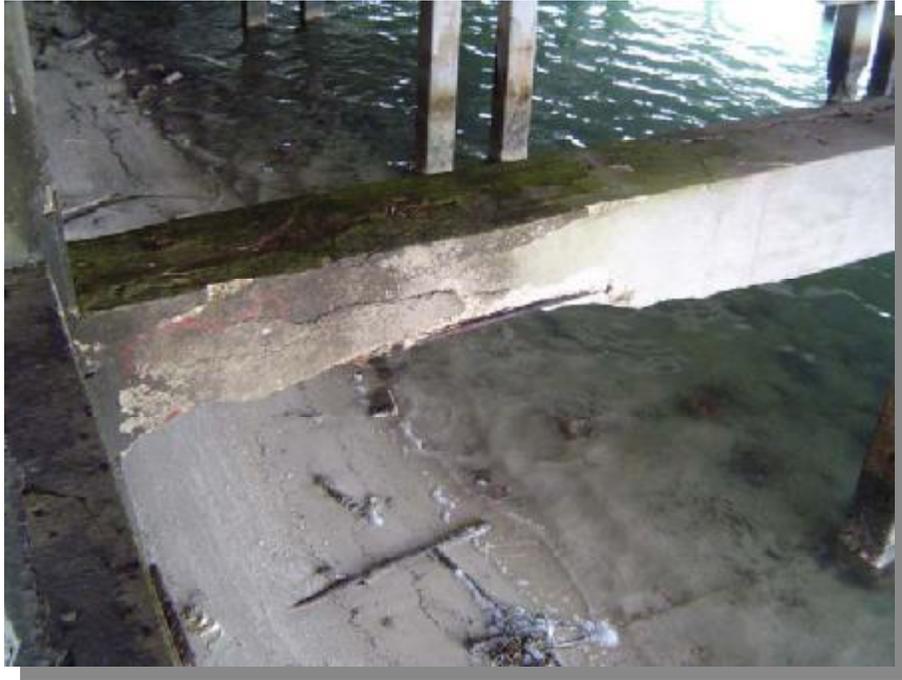
62- Concrete Beam Damage

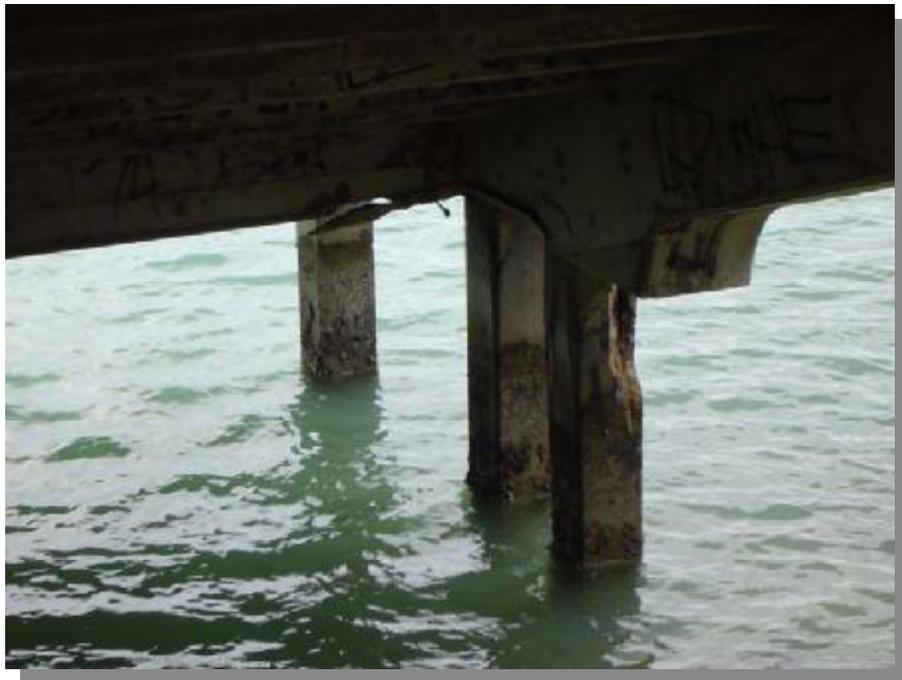
63- Column and Beam Damage

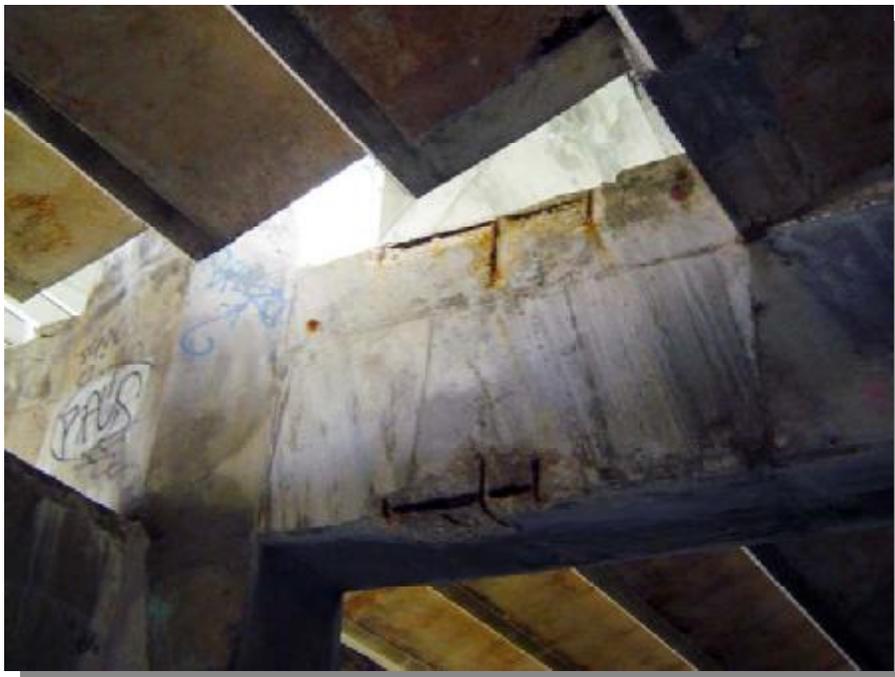
65- Main Support Beam Deterioration

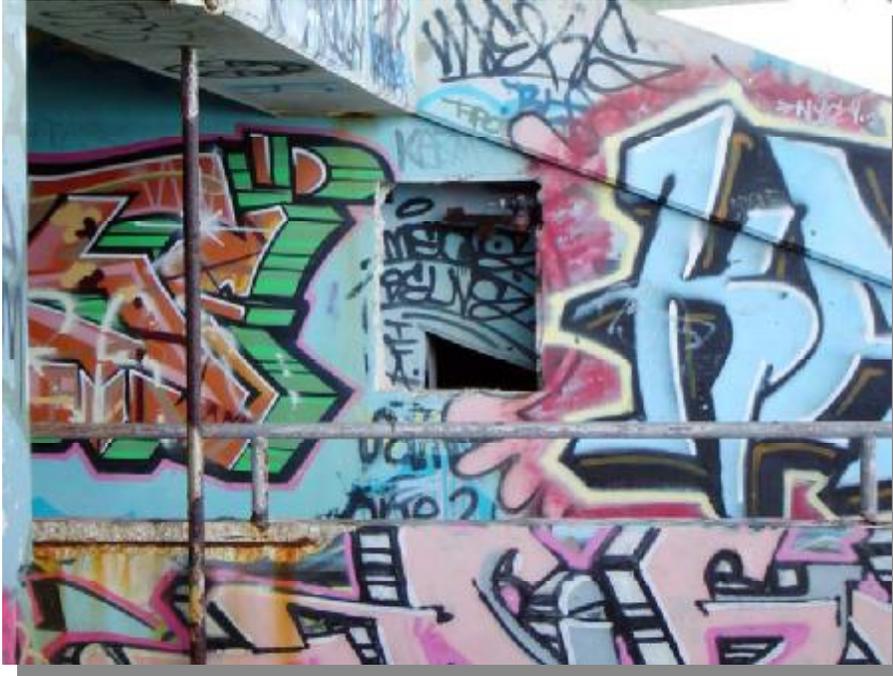
66- Main Ramp Support Beam Deterioration

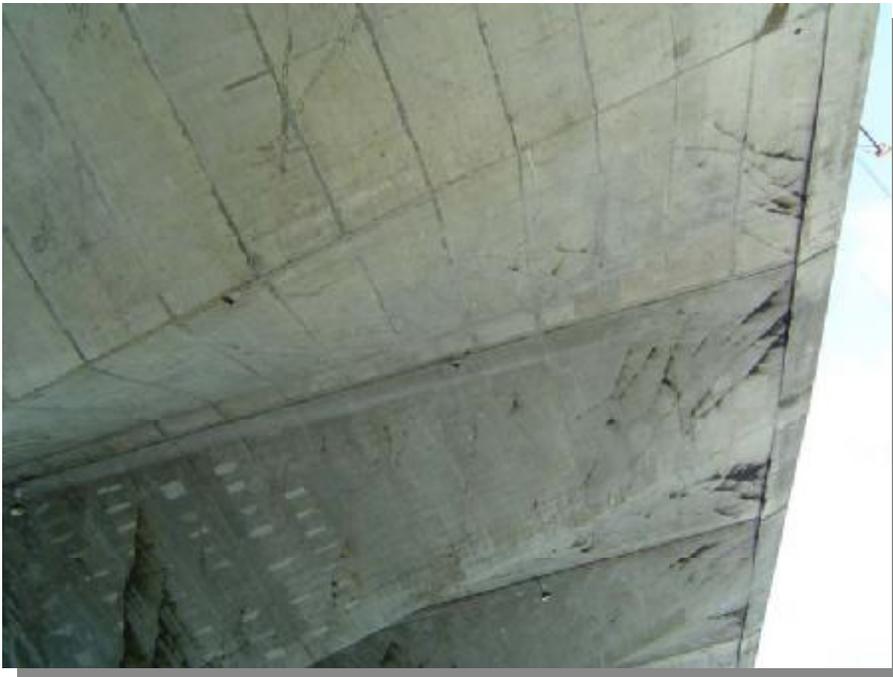
67- Over Head Concrete Structure with Water Seepage

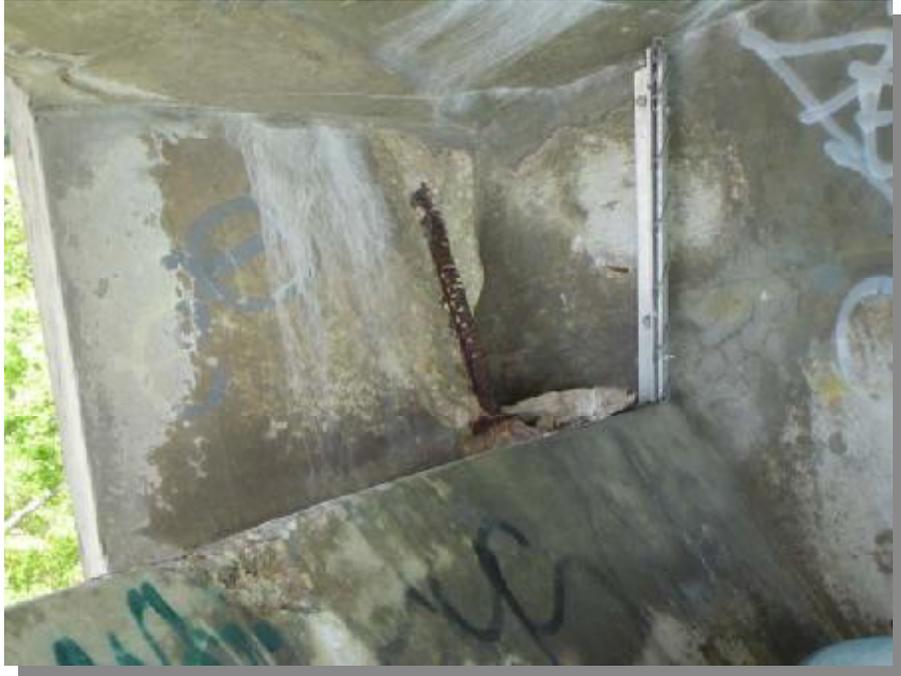
68- Main Column Deterioration
