**City of Miami
Marine Stadium
At
Virginia Key**

Existing Building Condition Assessment

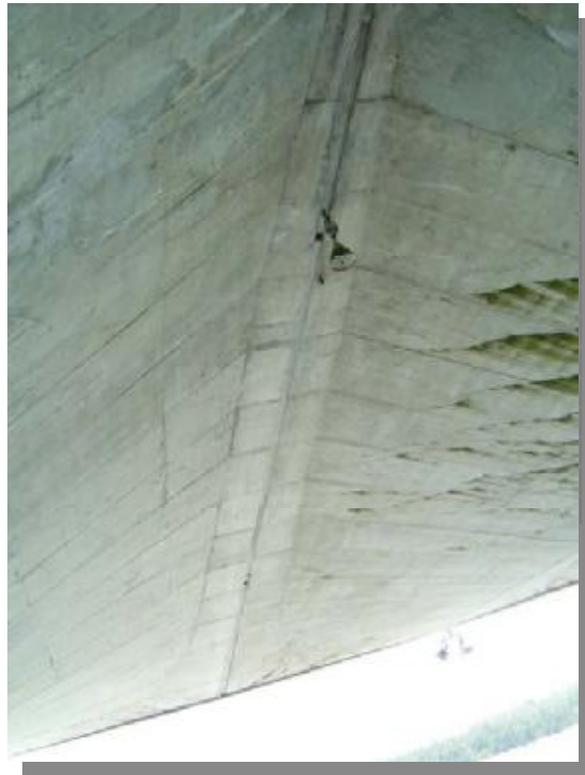
69- Over Head Canopy with Water Seepage

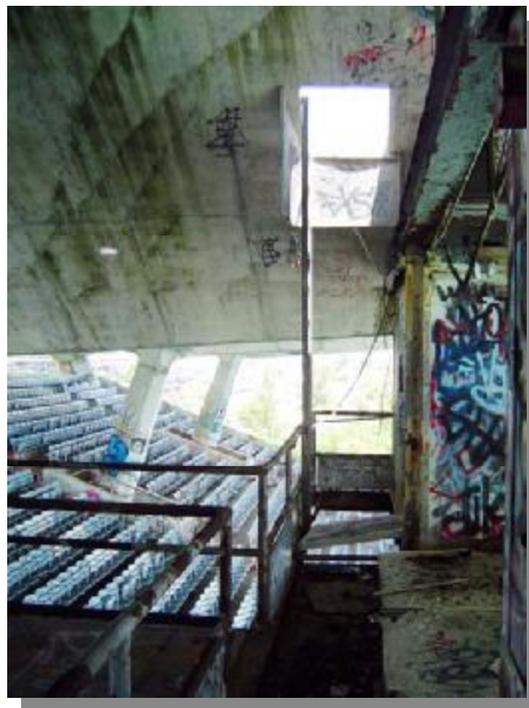
71- Control Booth Structure Deterioration

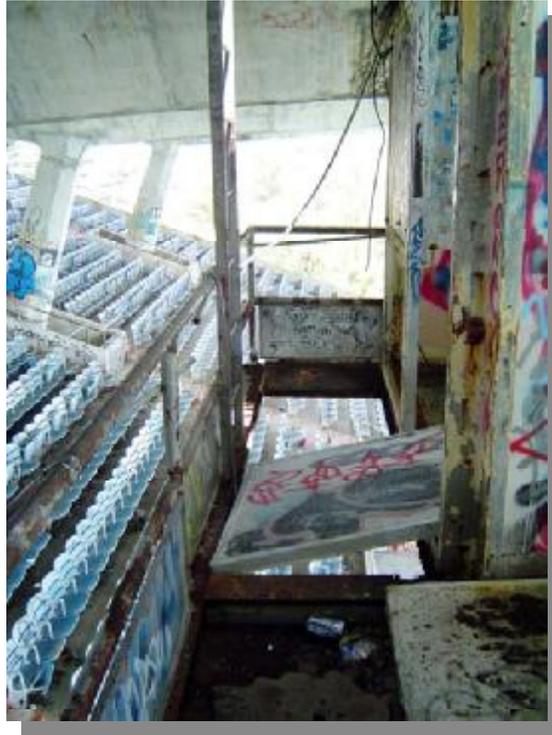
72- Control Booth Structure Deterioration

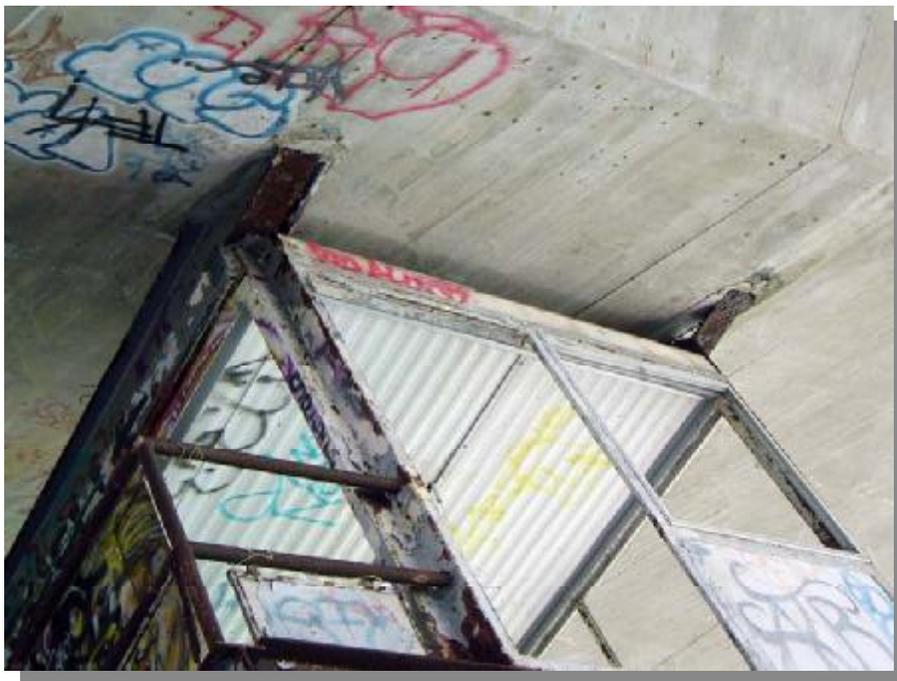
73- Control Booth Support Structure Deterioration

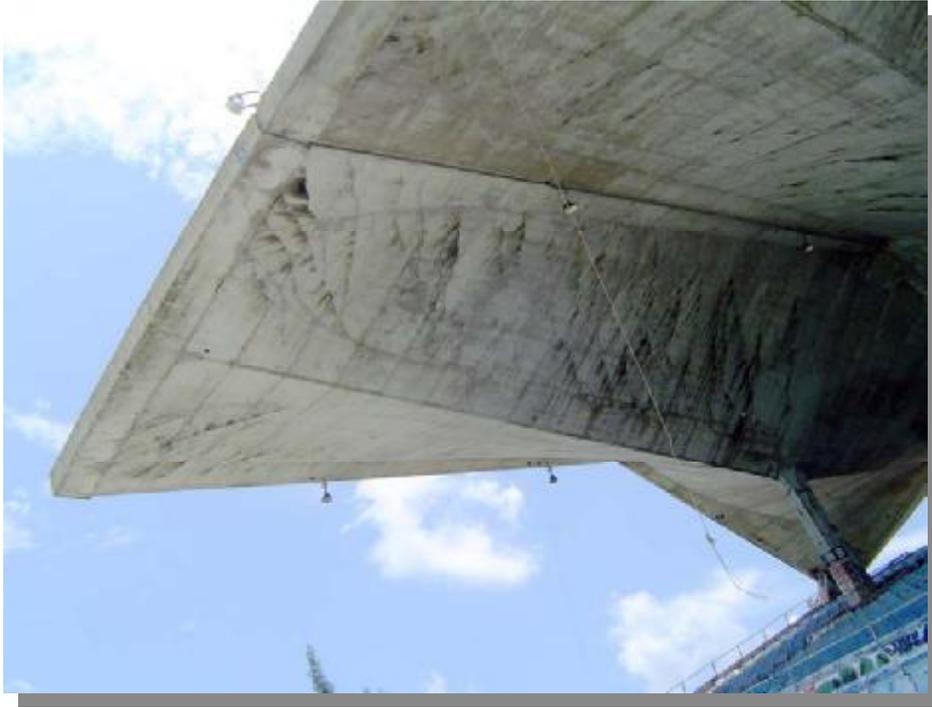
74- Over Head Concrete Structure with Water Seepage

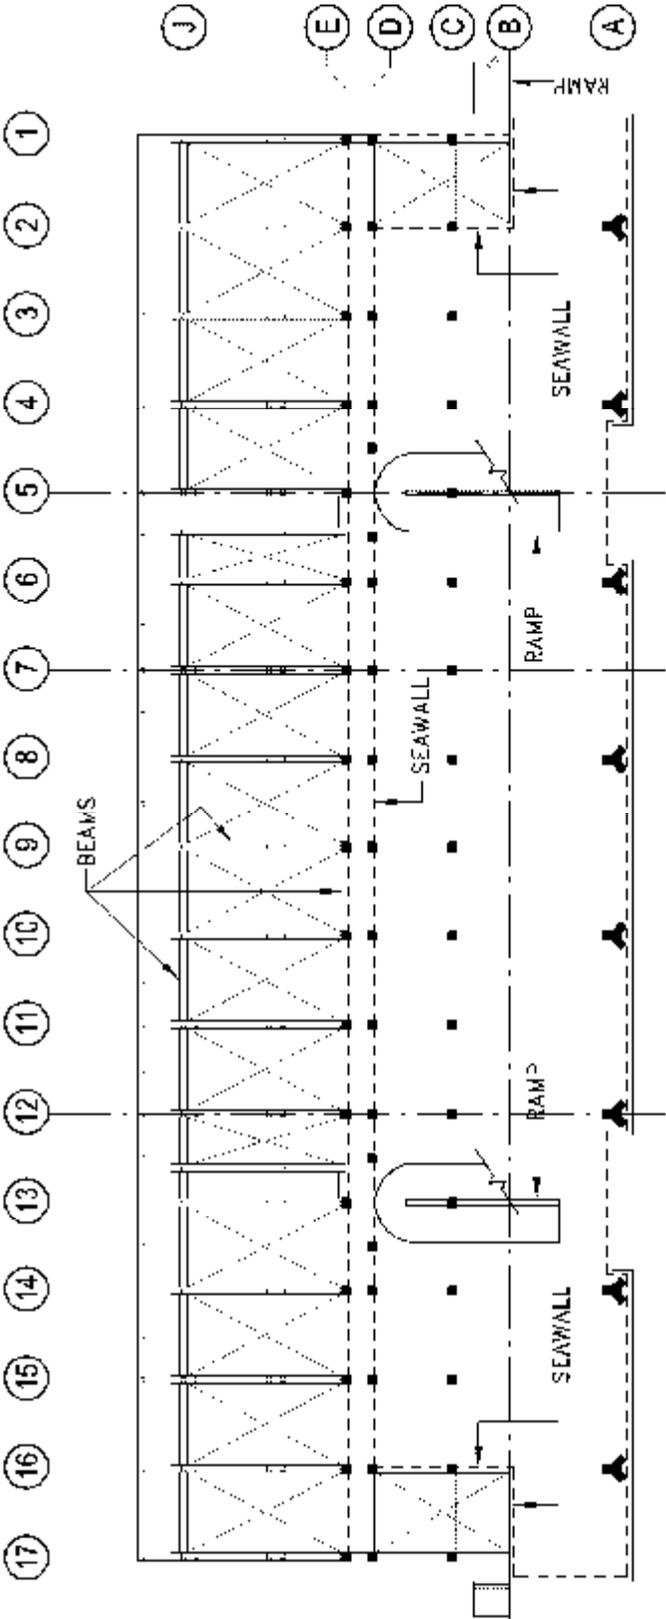
GROUND LEVEL AND FRAMING BELOW LOWER SEATING

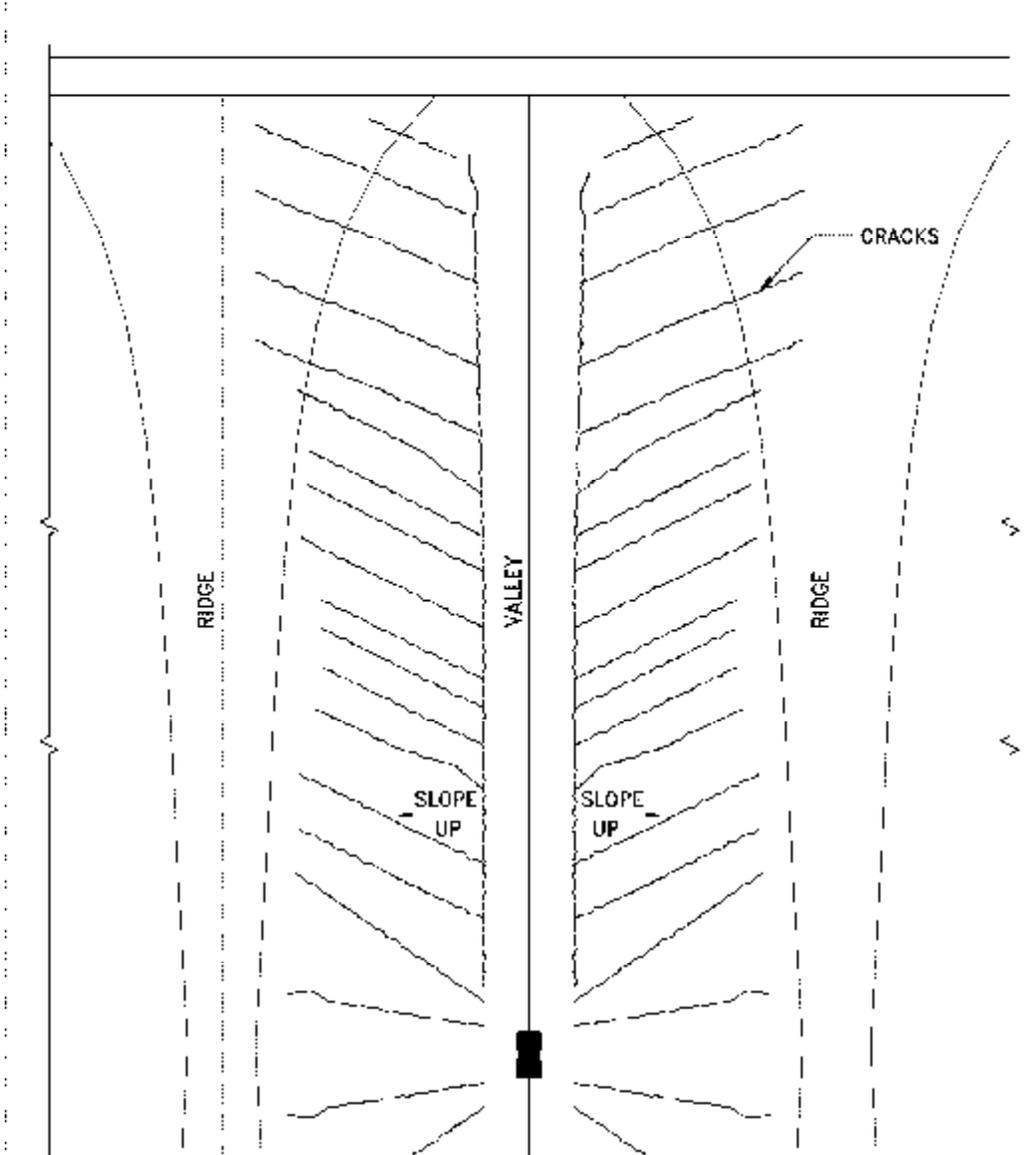
PARTIAL ROOF PLAN OF TYPICAL CRACK PATTERN

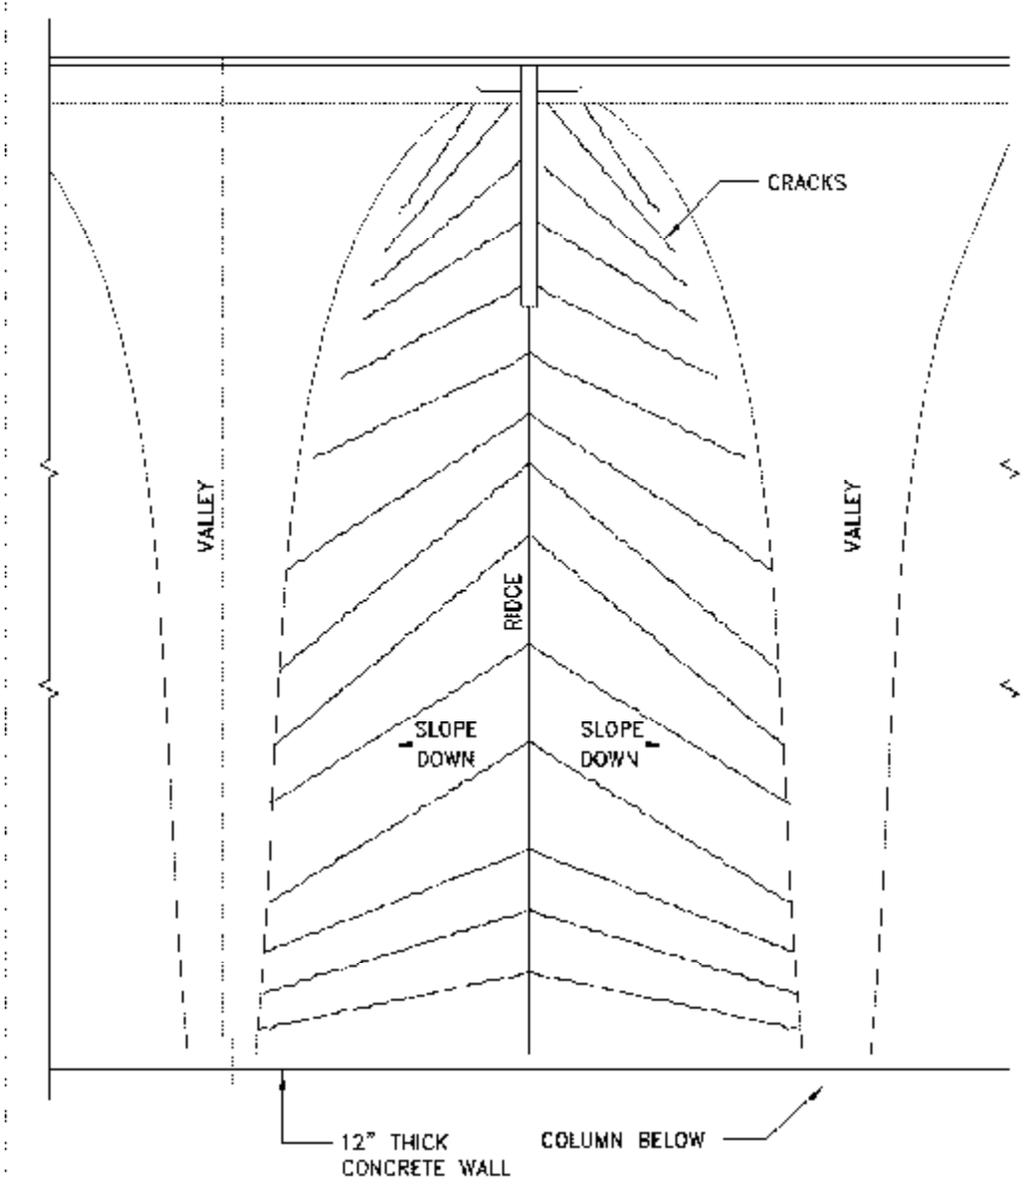
PARTIAL ROOF PLAN OF TYPICAL CRACK PATTERN

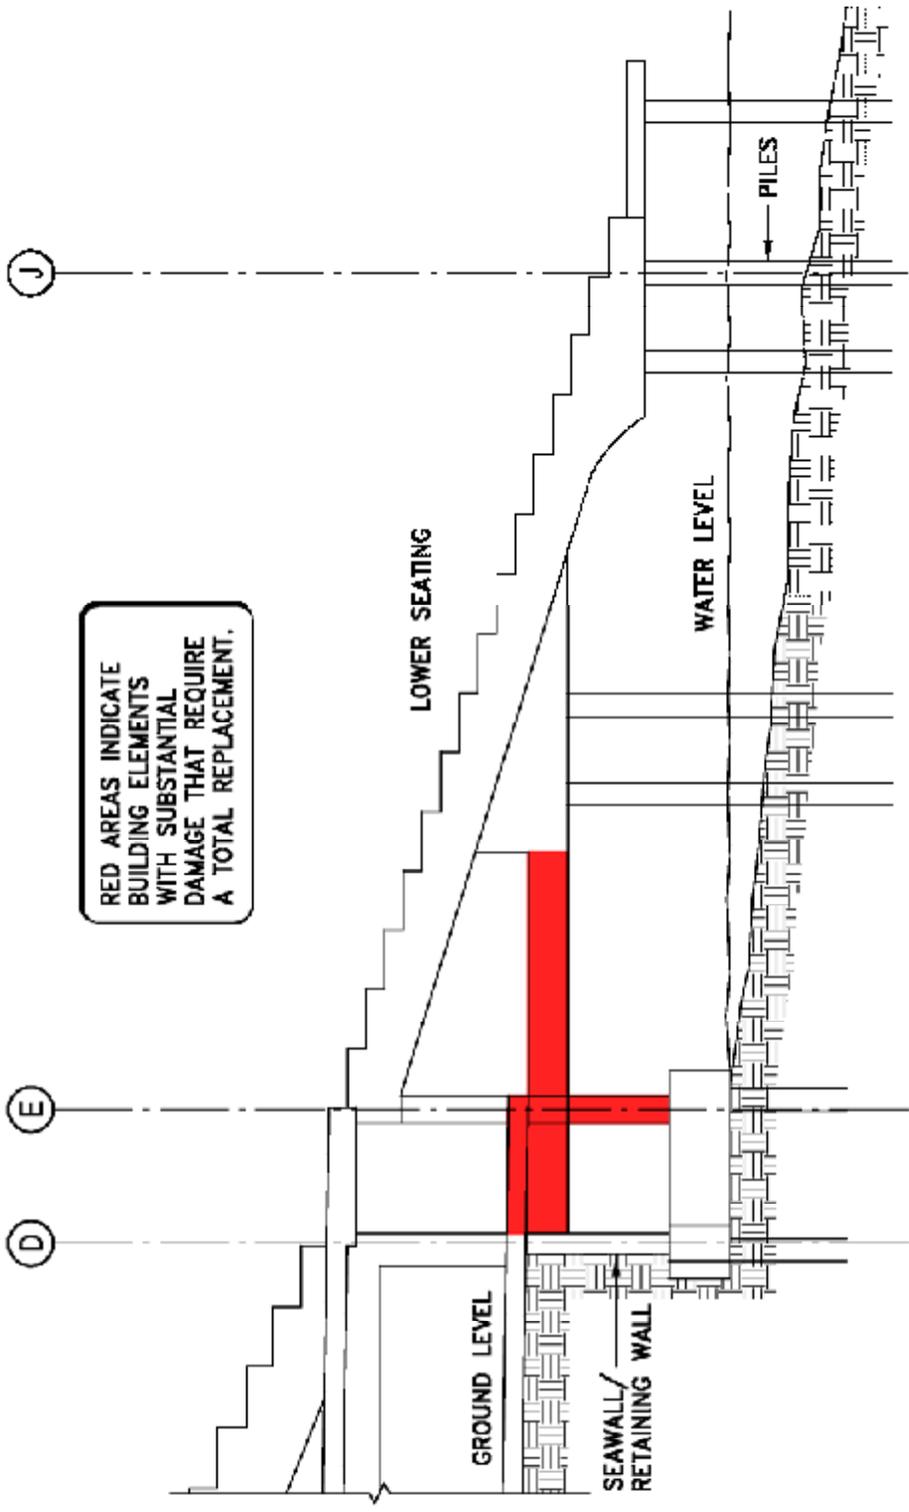
RED AREAS INDICATE BUILDING ELEMENTS WITH SUBSTANTIAL DAMAGE THAT REQUIRE A TOTAL REPLACEMENT.
