Evaluating Current Conditions of Miami Marine Stadium

Despite years of neglect, it appears that the structure can be repaired

BY MICHAEL L. BRAINERD, J. GUSTAVO TUMIALAN, AND MATTHEW B. BRONSKI

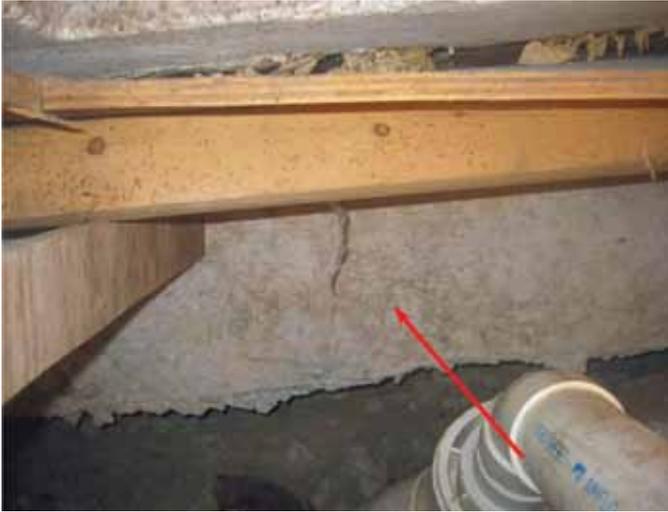
Fig. 4: The undersides of the slabs and grade beams are in good condition (photo courtesy of SGH)

openings, we were able to observe that the underside of the slabs and grade beams are in good condition (Fig. 4); however, the mezzanine slab has localized areas of severe deterioration primarily caused by embedded steel hangers supporting the slab (Fig. 5).

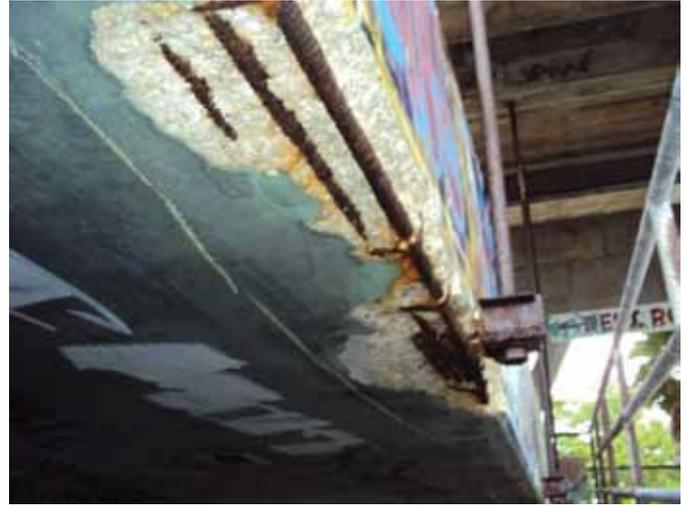
Fig. 5: Deterioration in mezzanine slab at hanger location (photo courtesy of SGH)

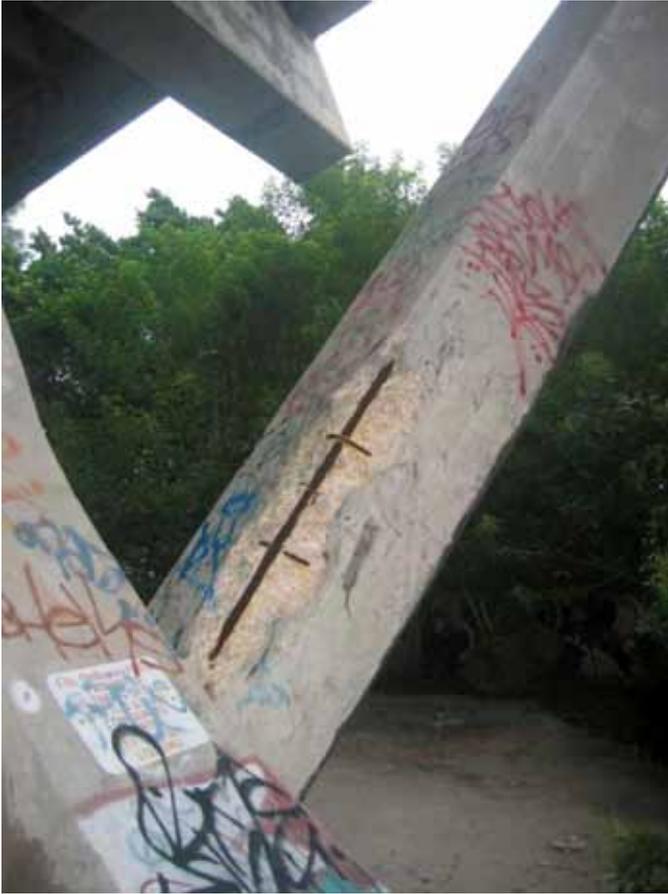
The seating areas, vomitory and parapet walls, raker beams supporting the seating structure, and inclined columns supporting the roof structure (Fig. 6) show moderate deterioration with localized spalls or delaminations. Several parapets around the inclined front columns show severe deterioration, and the beams next to the uppermost seating row show severe localized deterioration.

Fig. 6: Deteriorated inclined column (photo courtesy of SGH)

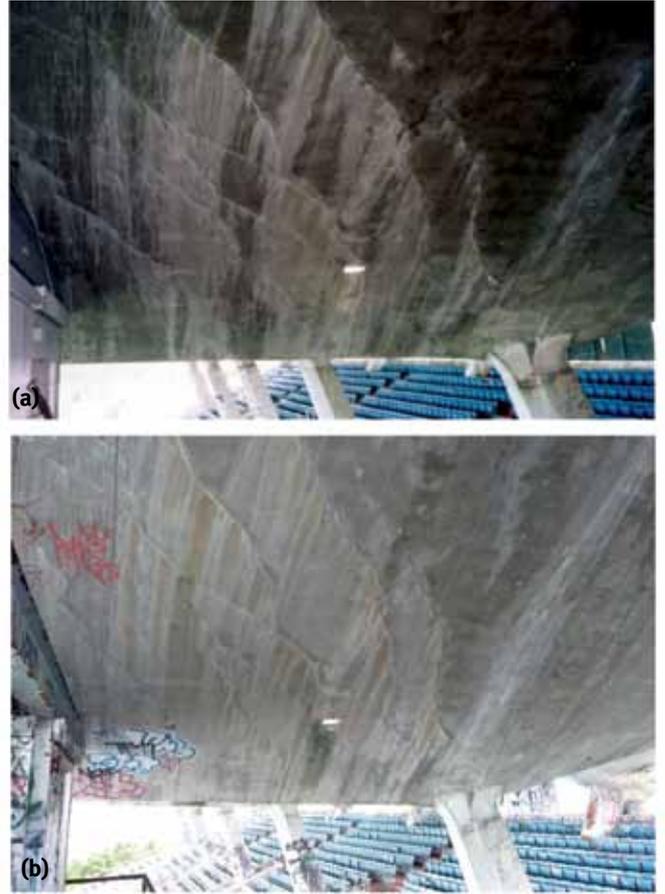
The roof shows diagonal cracks from 0.013 to 0.040 in. (0.330 to 1.016 mm) wide throughout the front cantilever portion. The severity and extent of corrosion of the reinforcement, however, were less than might be expected because of the use of galvanized reinforcement in the roof. Some post-tensioning anchorage zones of the roof diaphragm are spalled or delaminated.

When compared with the conditions found in 1993, deterioration doesn't appear to have increased alarmingly. For instance, the cracking on the roof (Fig. 7), deterioration of one of the post-tensioning anchorage zones (Fig. 8), and spalling of columns (Fig. 9) don't appear to have increased significantly. We did observe a tie beam over the water with large spalled areas that weren't observed in 1993 (Fig. 10). It should be noted that since these observations were limited to the elements or areas that we were able to identify in photographs or notes from 1993, we can't generalize the observed deterioration rate for the balance of the structural elements in the stadium.

Fig. 7: Cracking on bottom side of roof: (a) 1993; and (b) 2009 (photos courtesy of SGH)

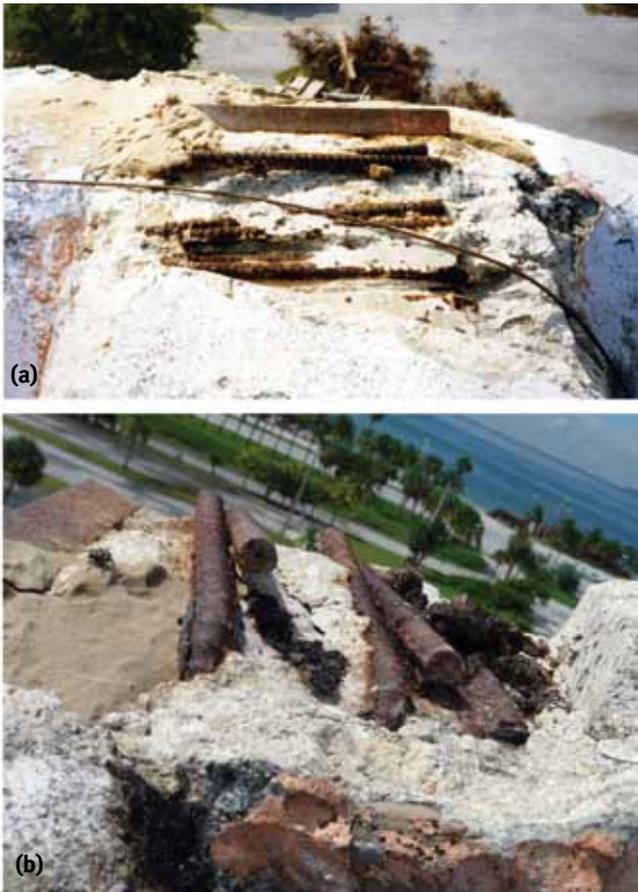
Fig. 8: Deterioration of post-tensioning anchorage zone of the diaphragm end: (a) 1993; and (b) 2009 (photos courtesy of SGH)

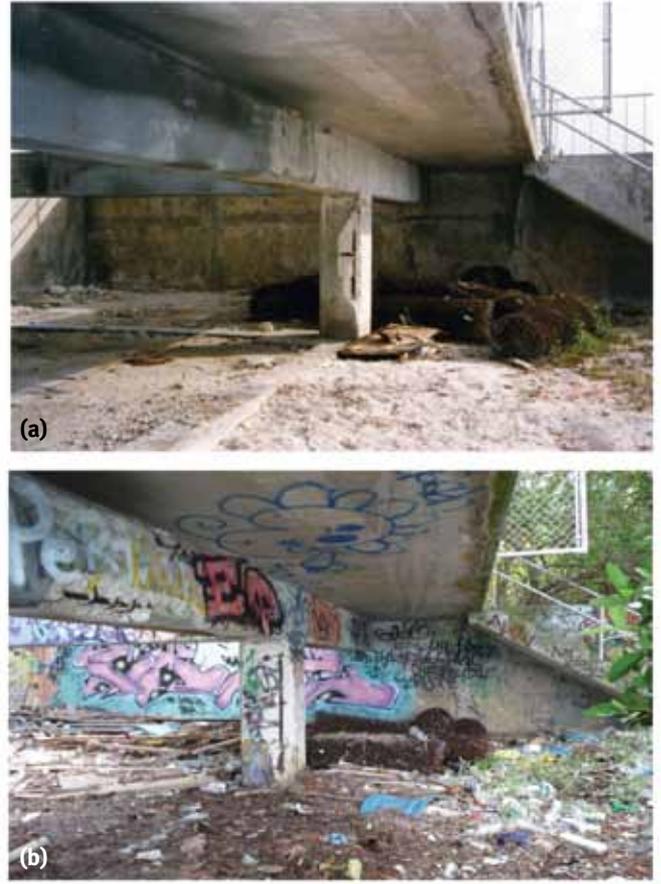
Fig. 9: Column showing increased spalling: (a) 1993; and (b) 2009 (photos courtesy of SGH)

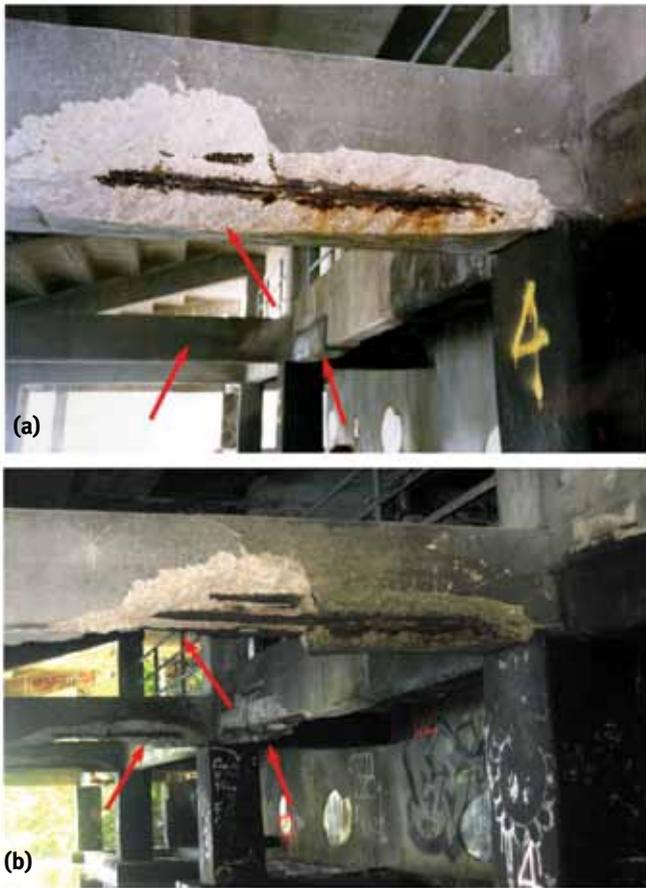
Fig: 10: Beams over water showing growth of spalls and new spalls: (a) 1993; and (b) 2009 (photos courtesy of SGH)
