Structural Repair  
and Protection  
Cost Estimate  
and Attendant  
Condition  
Appraisal of the  
Miami Marine  
Stadium

Miami, FL  
January 2010

SGH Project 090457

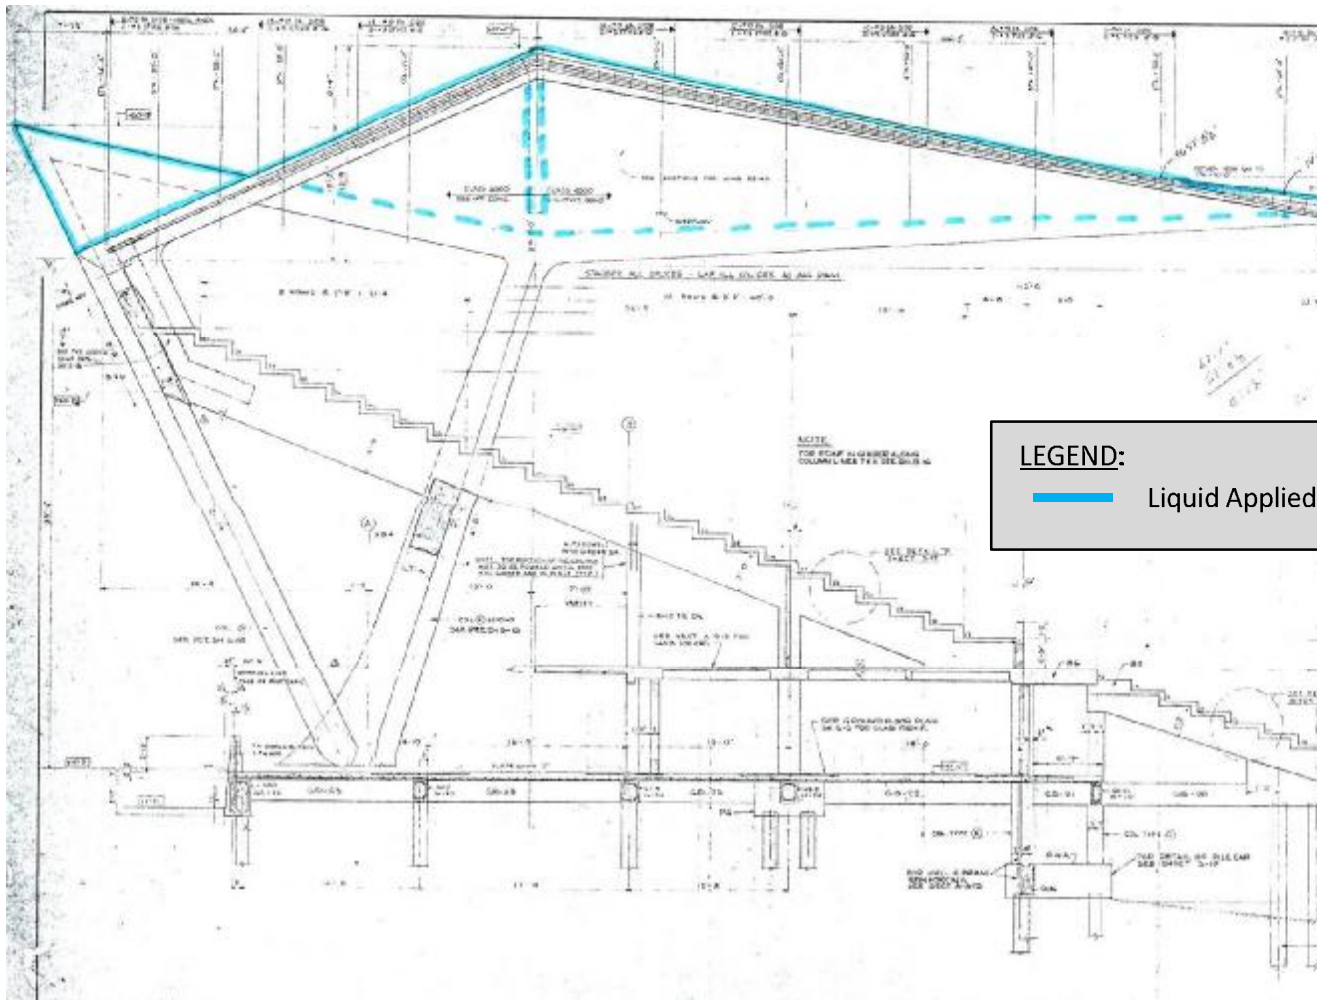
Figure 1. Concrete Protection – Alternative 1

Figure 1 illustrates the members receiving corrosion mitigation systems for this alternative.

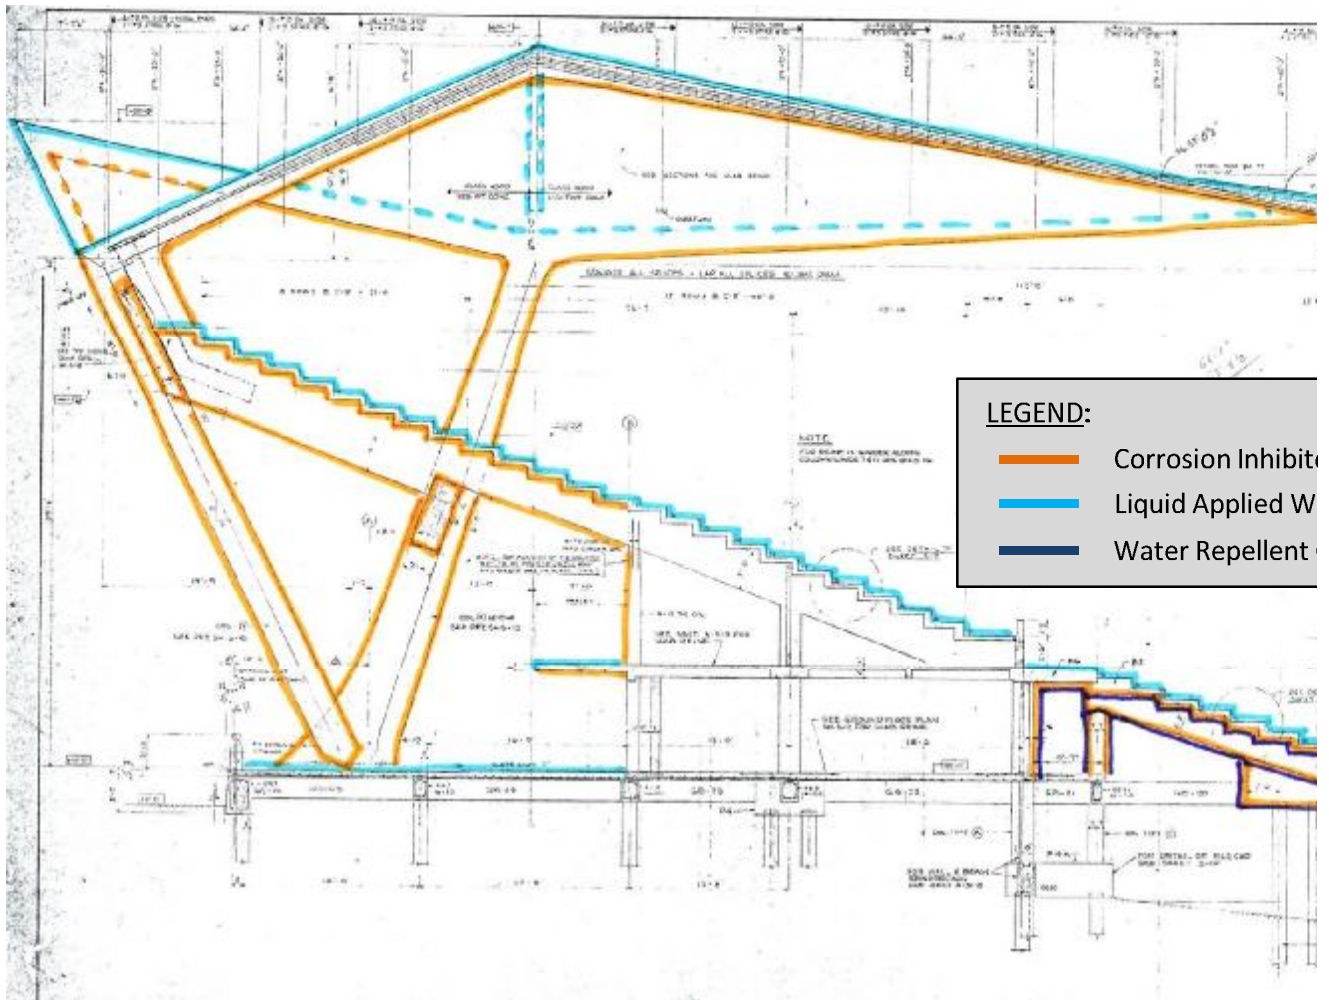
**Figure 3. Concrete Protection – Alternative 3**

Figure 3 illustrates the members receiving corrosion mitigation system for this alternative.

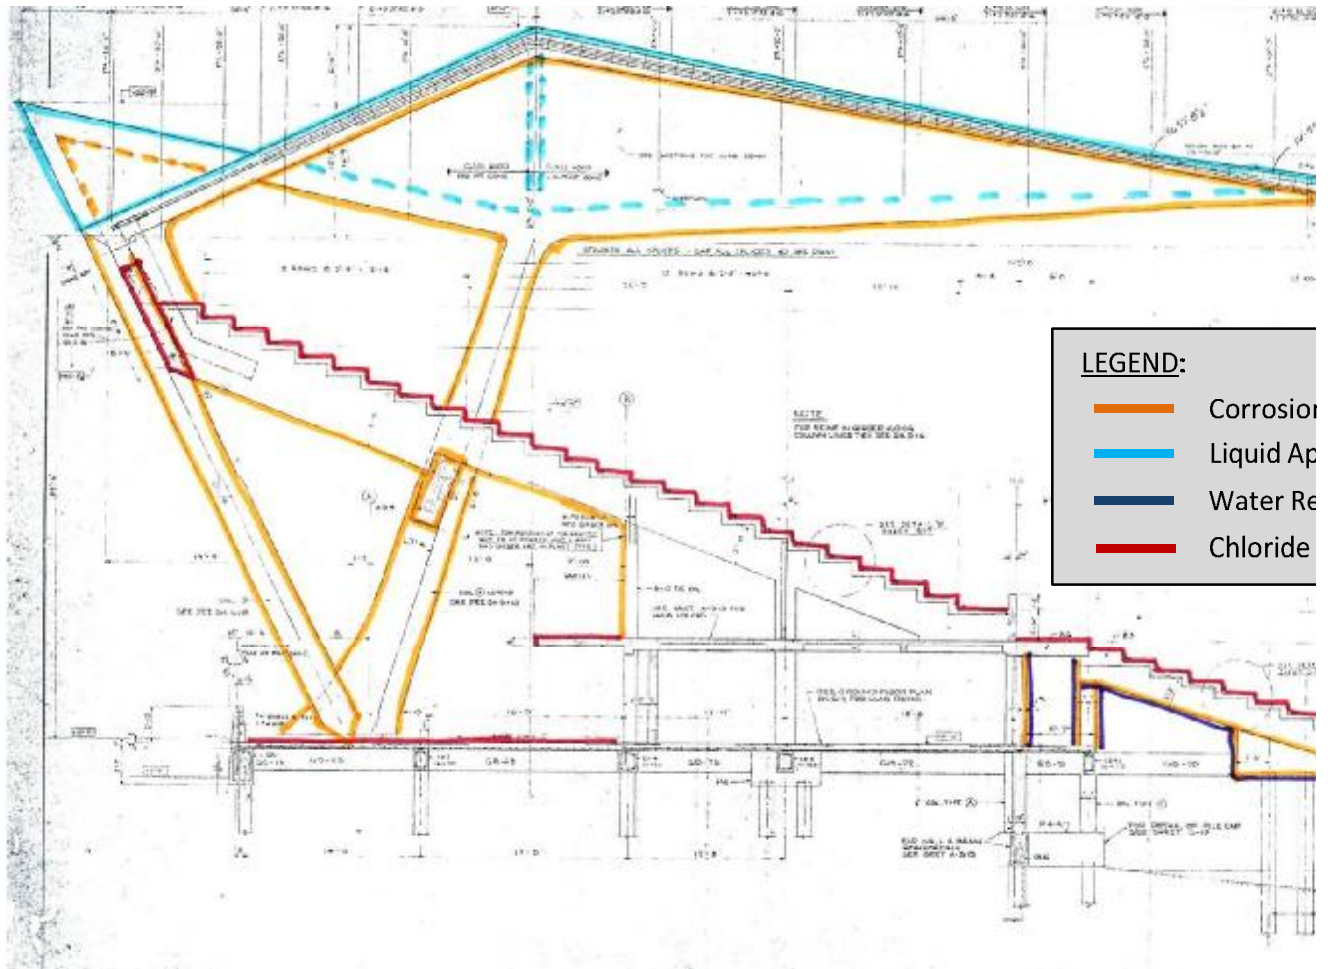
**Figure 4. Concrete Protection – Alternative 4**

Figure 4 illustrates the members receiving corrosion mitigation systems for this alternative.
